USS Charles F Adams DDG-2 Philadelphia Open House

May 17-18, 2010

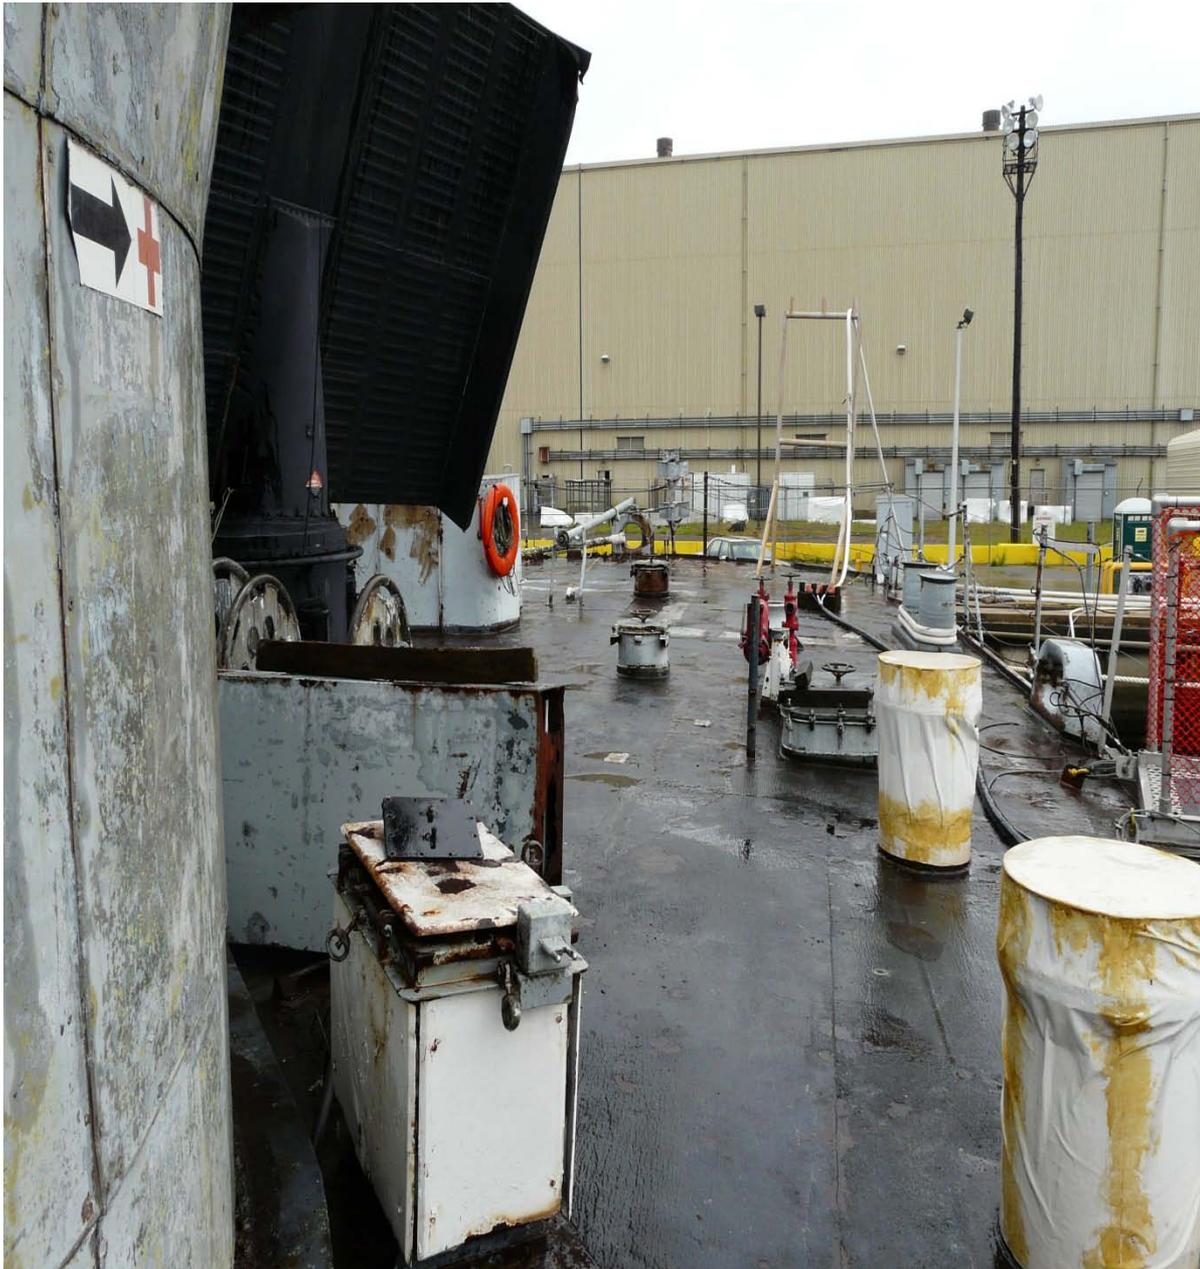
Port side looking aft

39 radar is bolted to a bracket that is welded to the main deck. Note that the air vents are sealed to prevent water infiltration. Also take note of the two storage lockers that are rusting. This is causing the rust stains that you see on the side of the ship. From the water line up the hull has no rust. The main deck also isn't rusting due to a clear sealer that has been applied. However non-skid is flaking off.

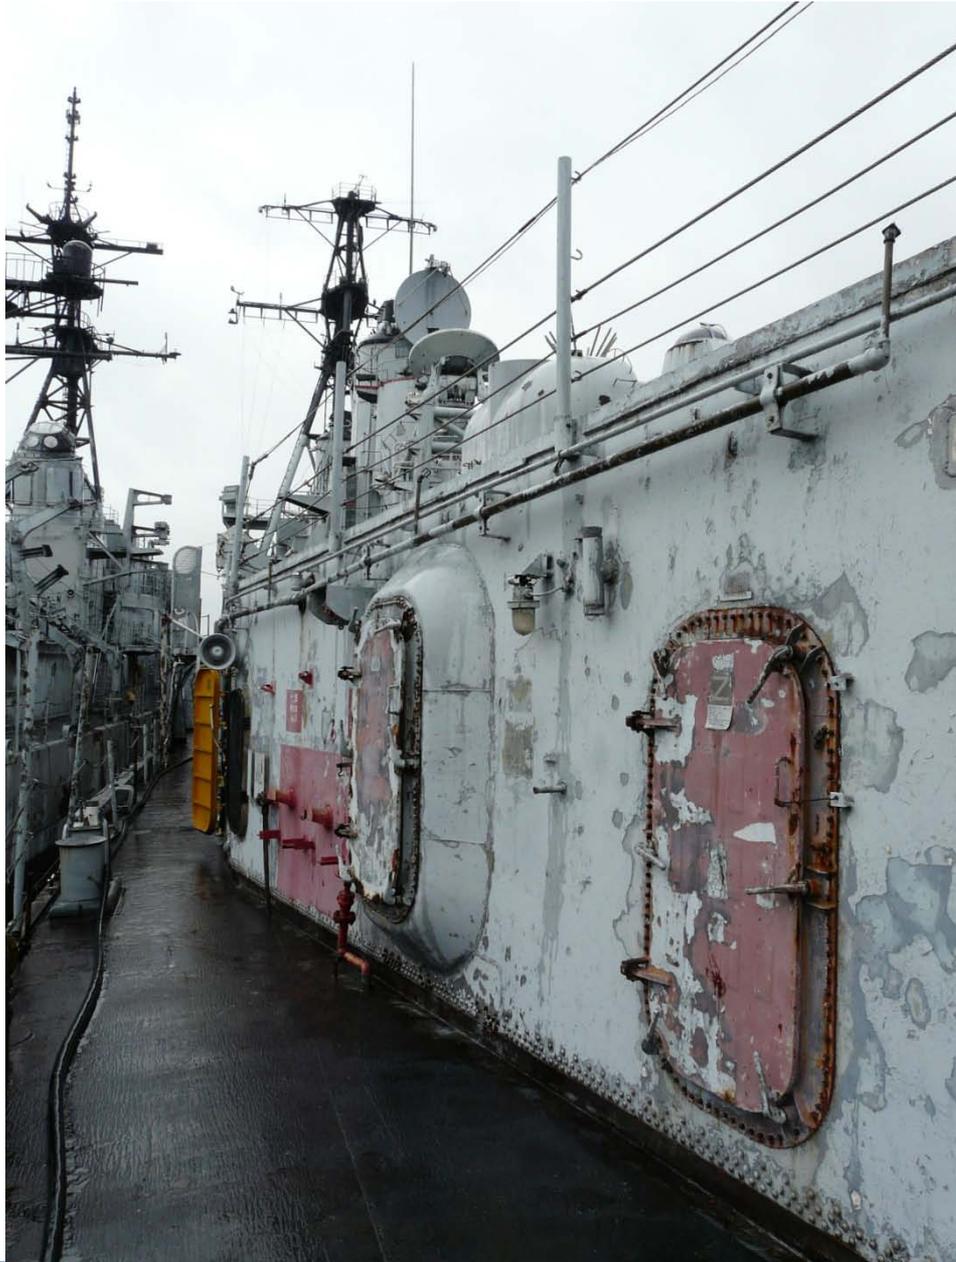
PORT SIDE AFT

Port side looking forward on the main deck. Note that the aluminum bulkheads had the paint flakes power washed off two years ago when a fresh coat of paint was applied to the hull from the waterline up to the main deck. The only rust you are seeing is on the water tight doors. Some doors will need replace while others can be repaired.

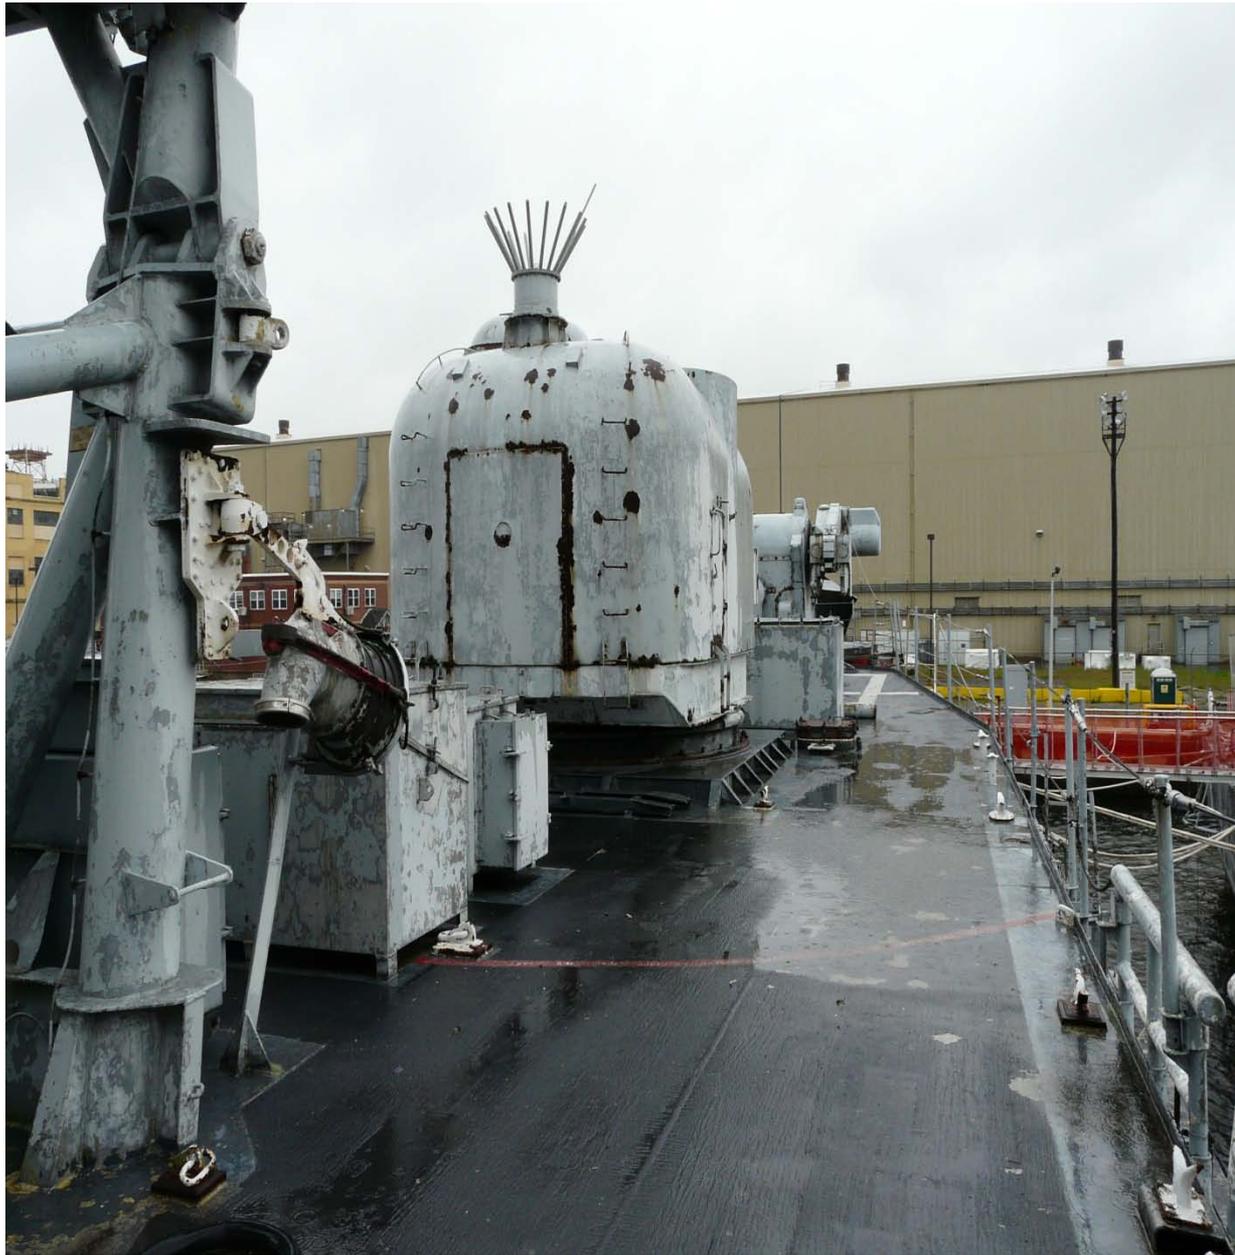
01 Level looking aft

The bird cage antenna on Gun Mount 52 has been cut down. There is some rust on the gun mount and missile launcher.

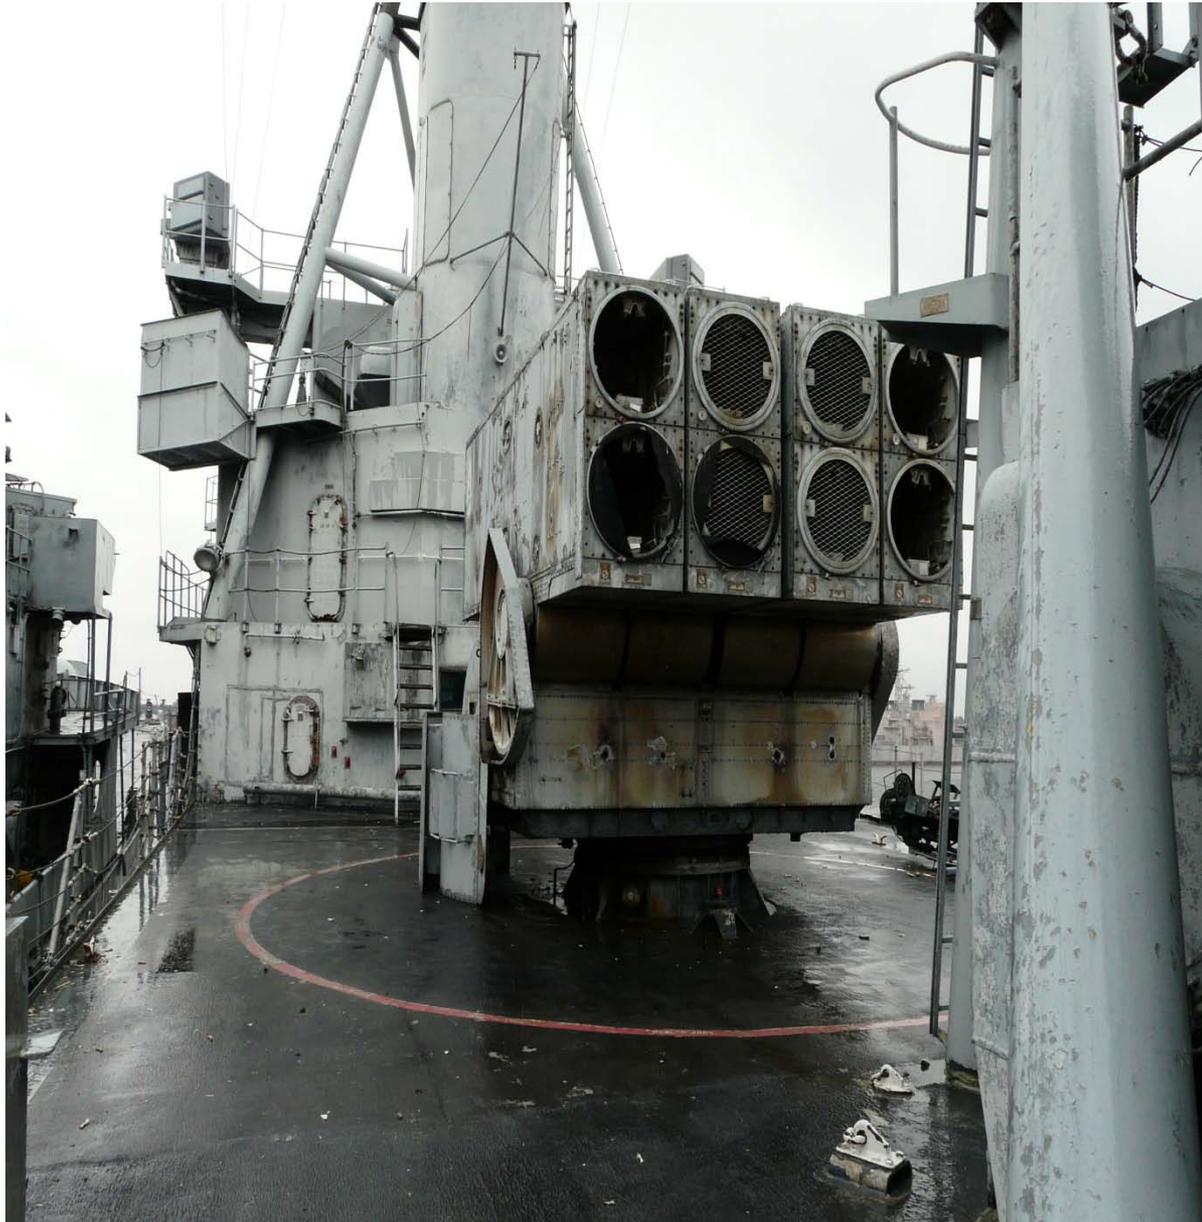
ASROC Deck

The ASROC Launcher does have rust all over but it is of the surface type. The cell covers are torn and will need replaced. Panels on the backside of the launcher need to be bolted back on. Take note just above the flag locker on the left upper part of the picture. The SLQ-32 Electronic Warfare Antennas are both still on the ship.

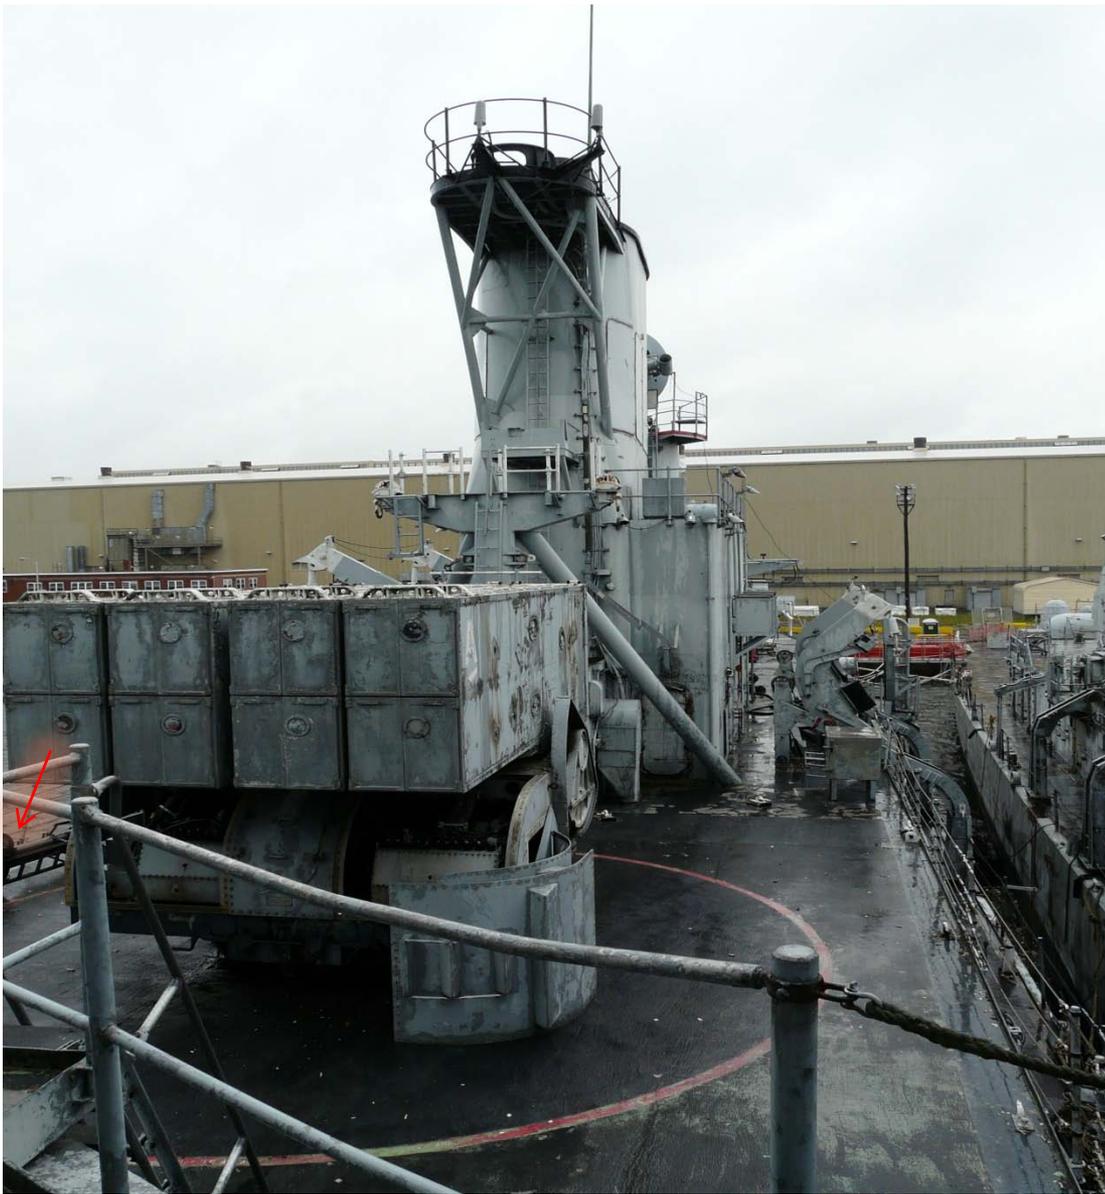
02 Level looking aft

You can see the covers to the front part of the ASROC Launcher leaning against the launcher. The 39 Radar which is normally mounted on the aft stack is missing and is welded on the fantail. Look at the red arrow on the left side of the picture. The item it is point to is the top part of the main mast that is setting on the deck.

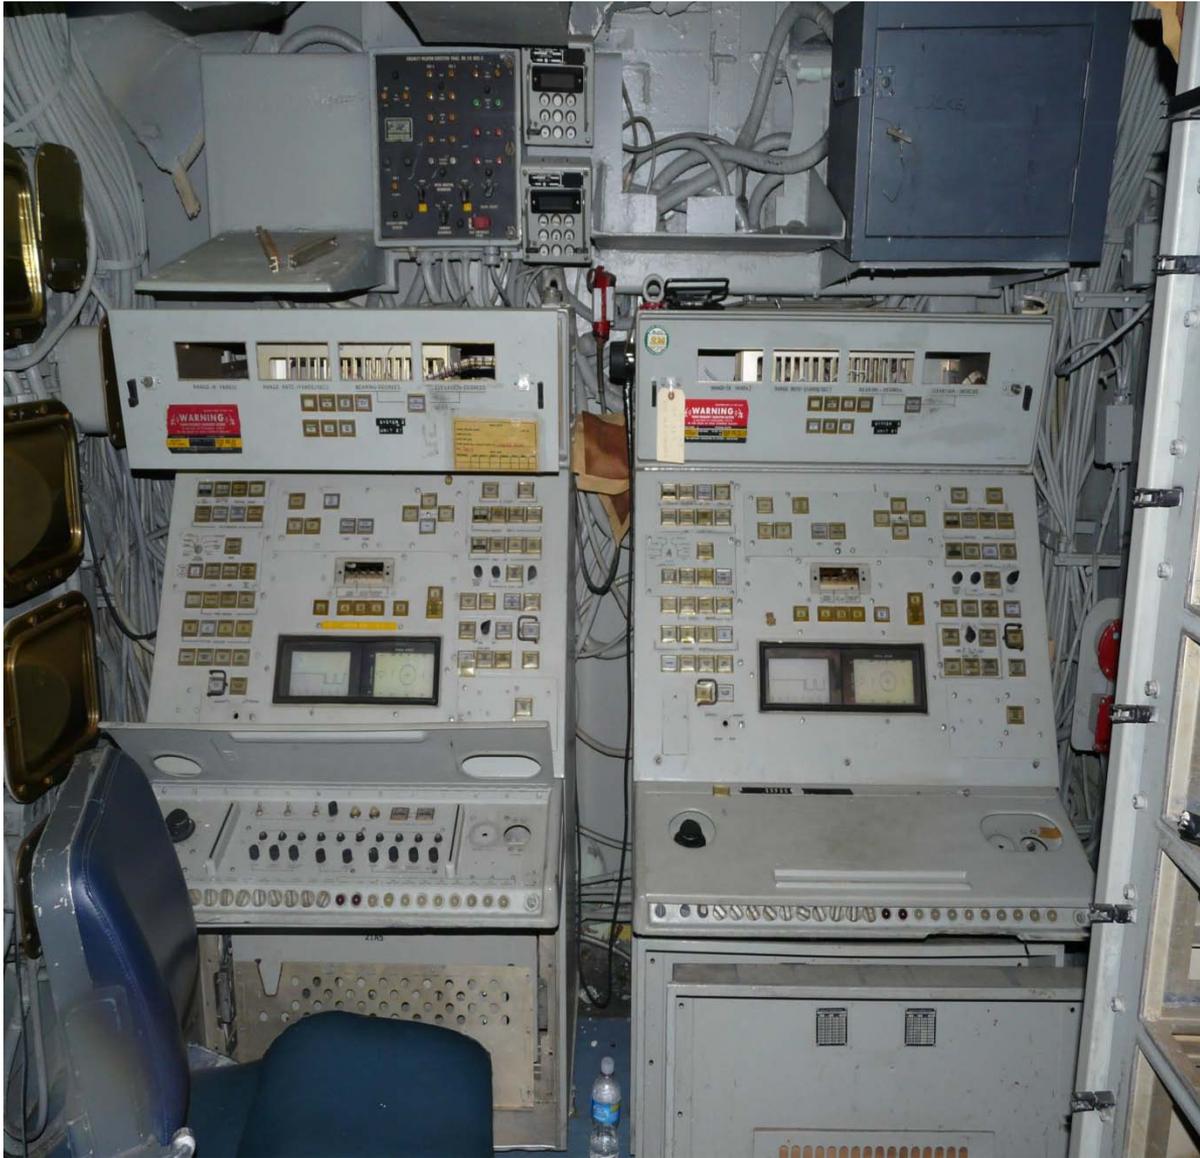
Missile Radar

These are the two radar consoles for the 51 radars. They have had some DEMILING done to them. They are located up a port side vertical ladder just forward of the aft gun mount on the 01 level.

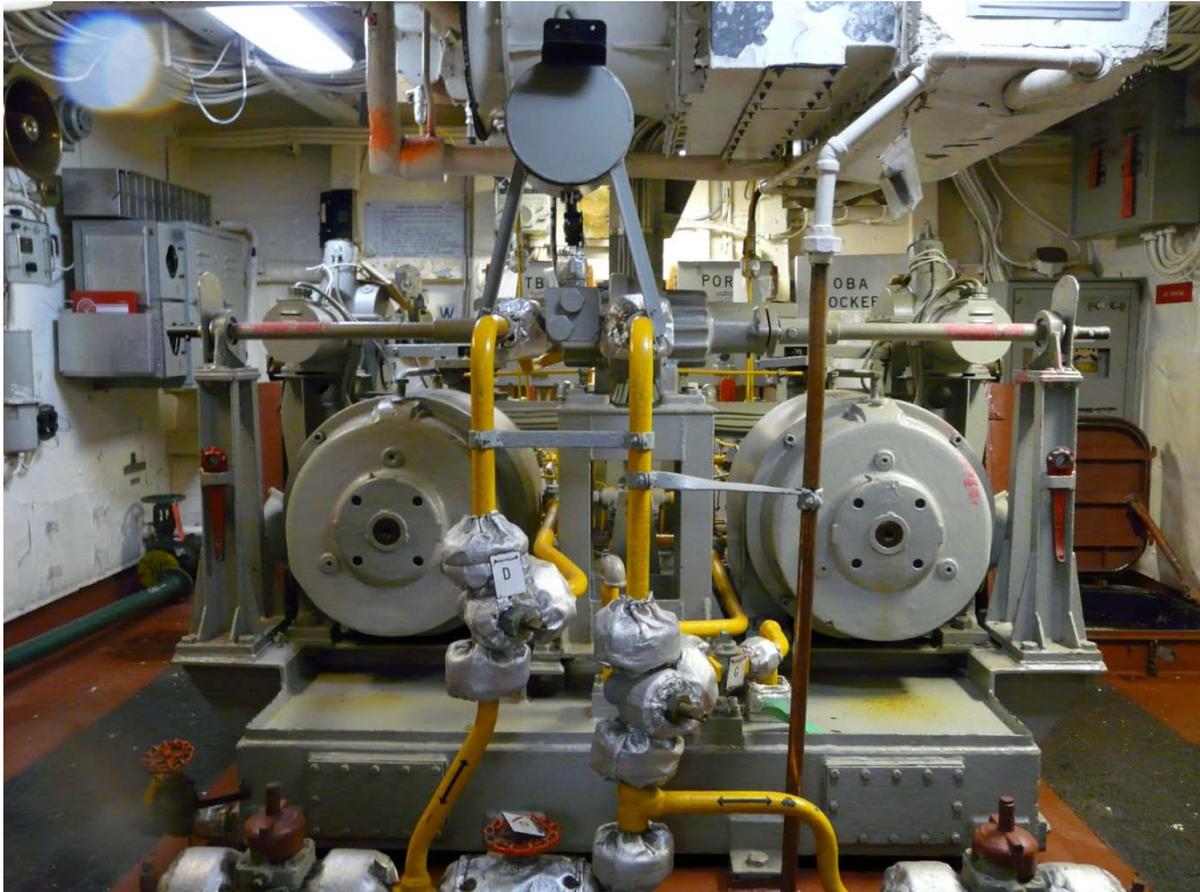
After Steering

This space is in excellent condition. Some minor repairs needed to the steering units is needed.

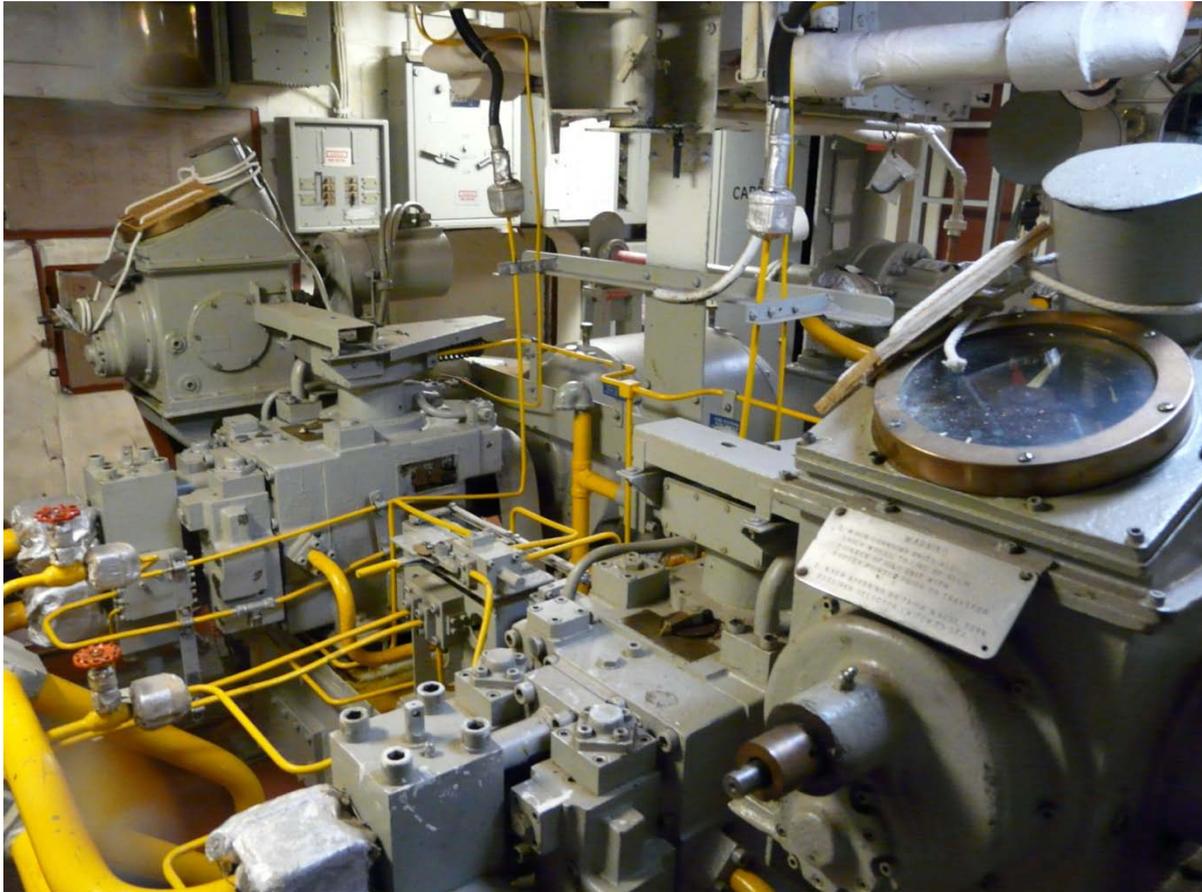
After Steering Units

Take note that the steering indicators are not smashed. The only items that appear to be missing are the small steering wheels on the port and starboard units.

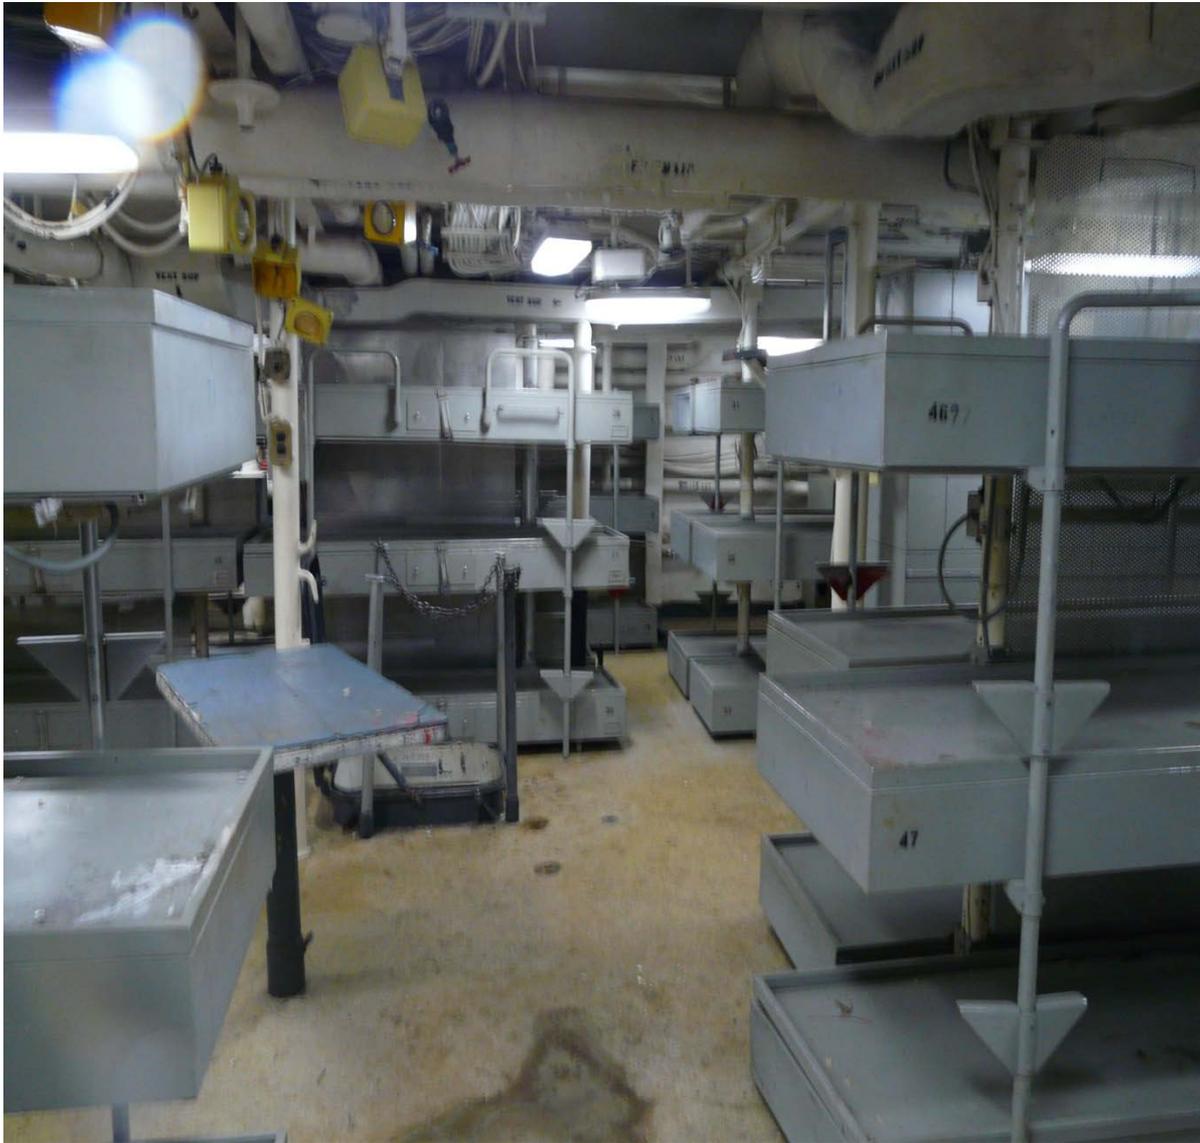
Engineering Berthing

All racks are present though some have been unbolted and pushed aside. The deck in this space will need to be upgraded.

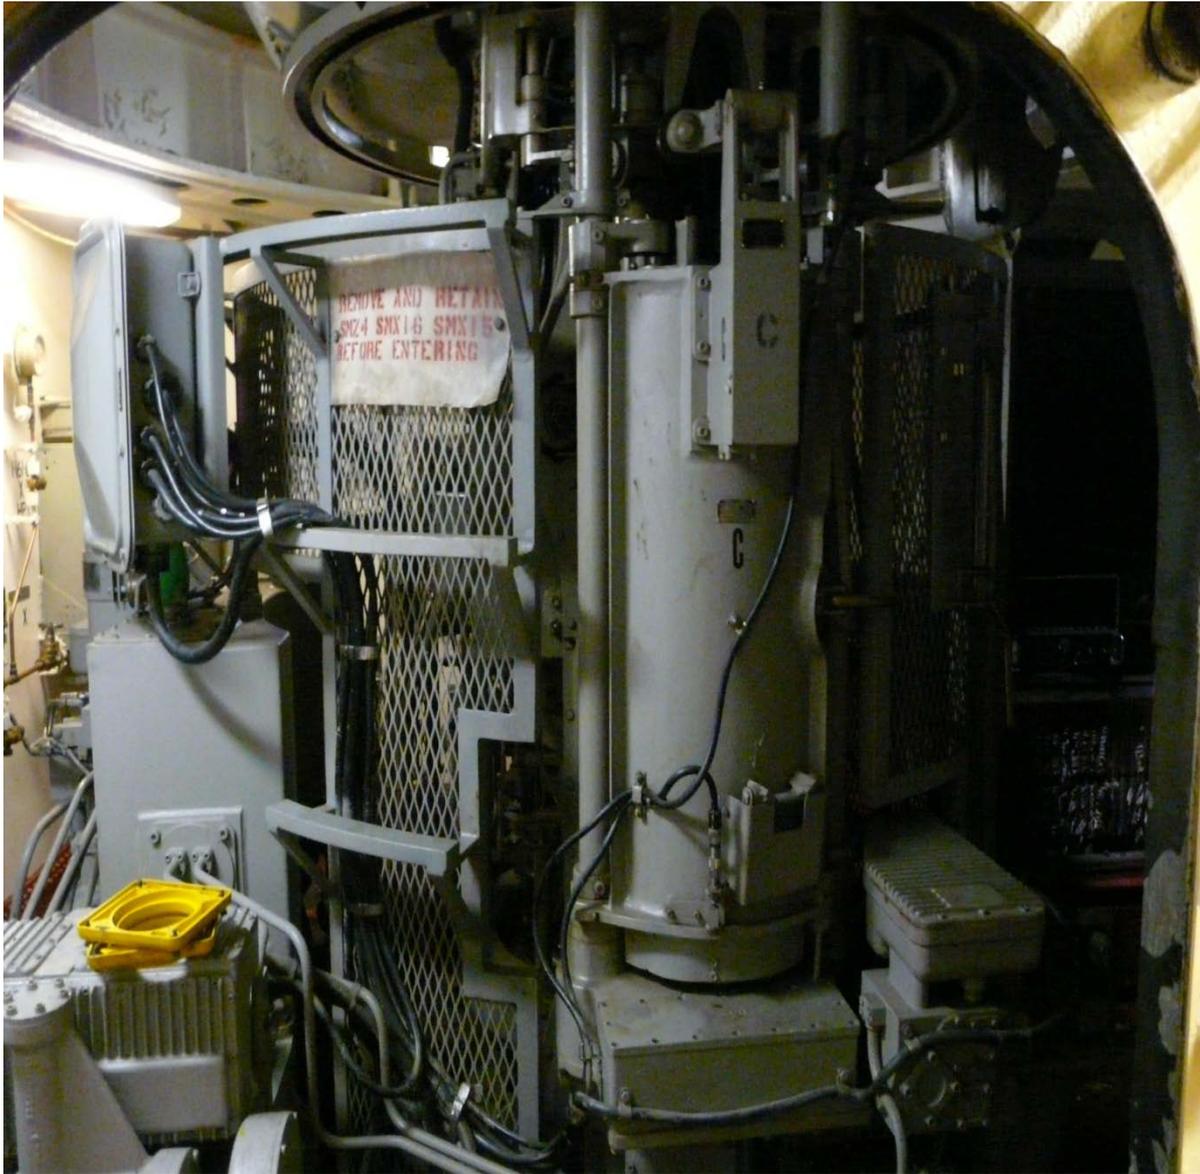
MT 52 Carrier Room

This is MT 52's carrier room just forward of the aft head. The DEMIL that took place in this space was to the EP 1 & 2 panels to the right which can't be seen in this photo. There is some hydraulic fluid on the deck, but even when the ships were in operation there always seemed to be some fluid on the deck.

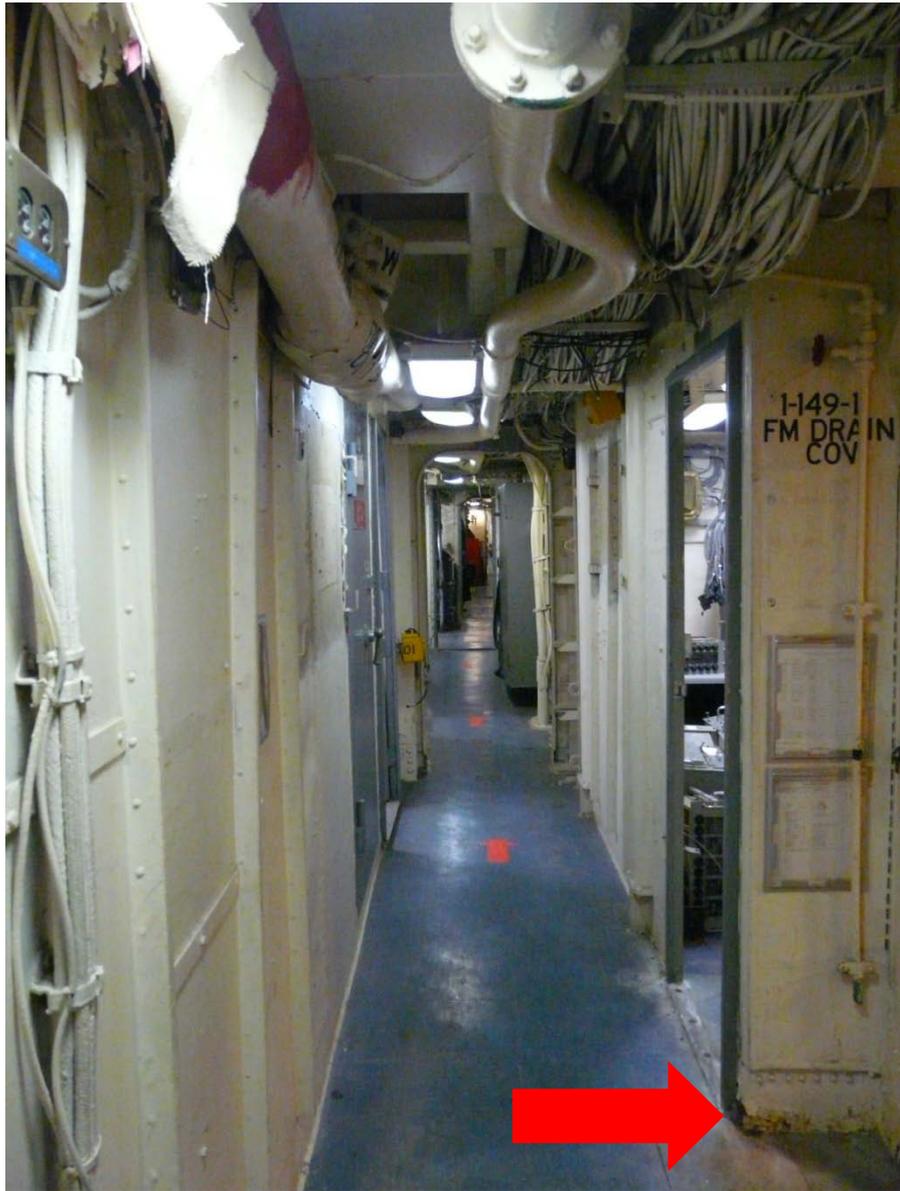
Main Ship Passageway Aft

This was taken from the MT 52 Carrier Room looking forward. As you can see the tile are coming off the deck and will need to be replaced with a terrazzo type deck. Look at the red arrow point right. There are places throughout the ship where there is rust that connects the bulkhead to the deck that will need repaired. For the most part, spaces will need to have flaking paint removed, wiped down, and repainted.

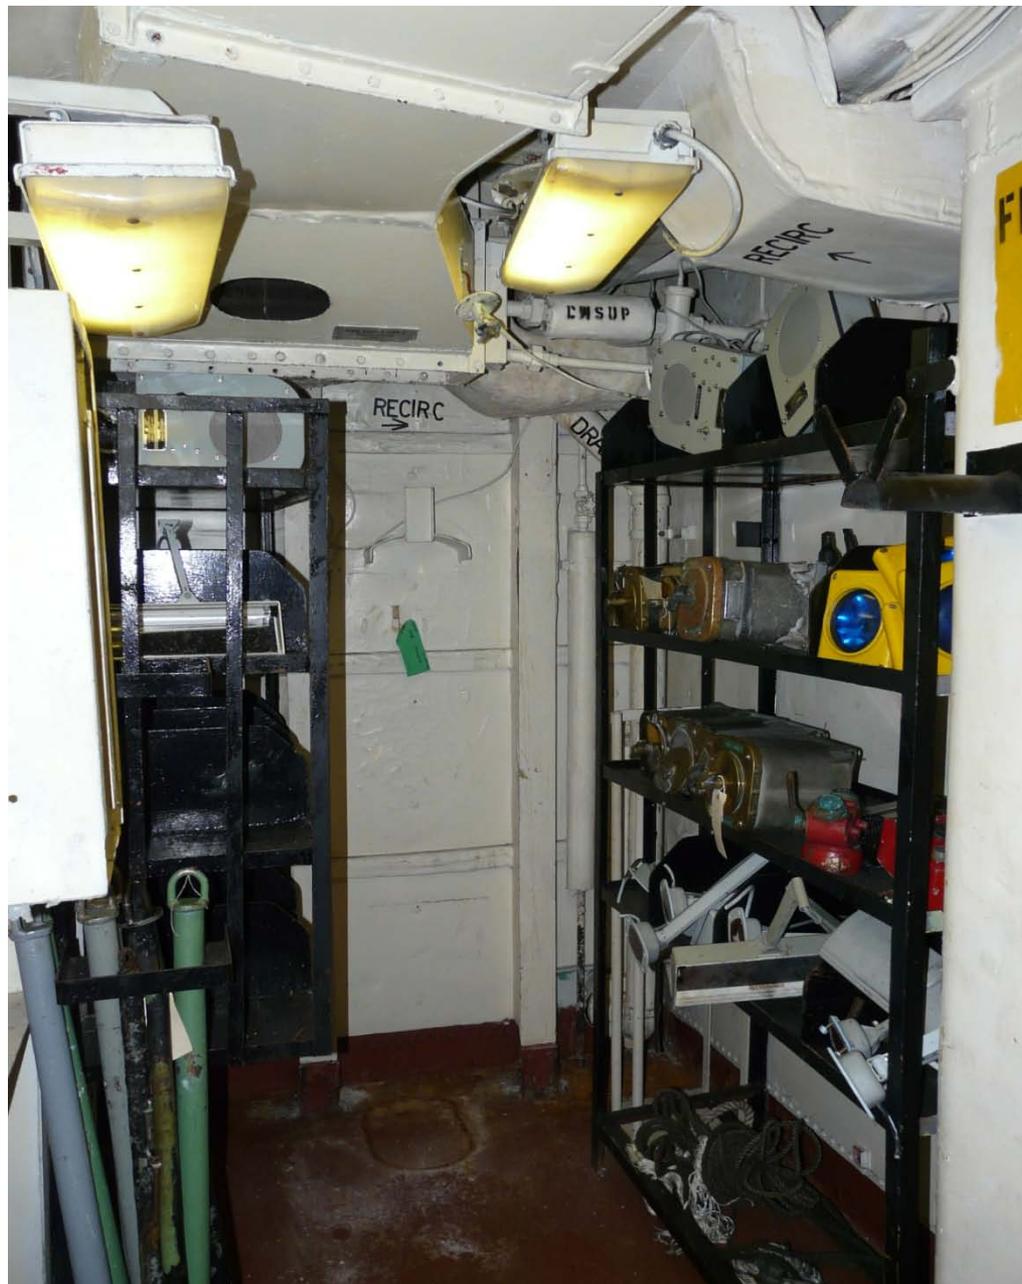
Damage Control Locker Repair 5

Repair 5 is in good shape like most of the interior spaces. It will need flaking paint removed, a good wipe down, and lastly repainted before restocking it with damage control equipment.

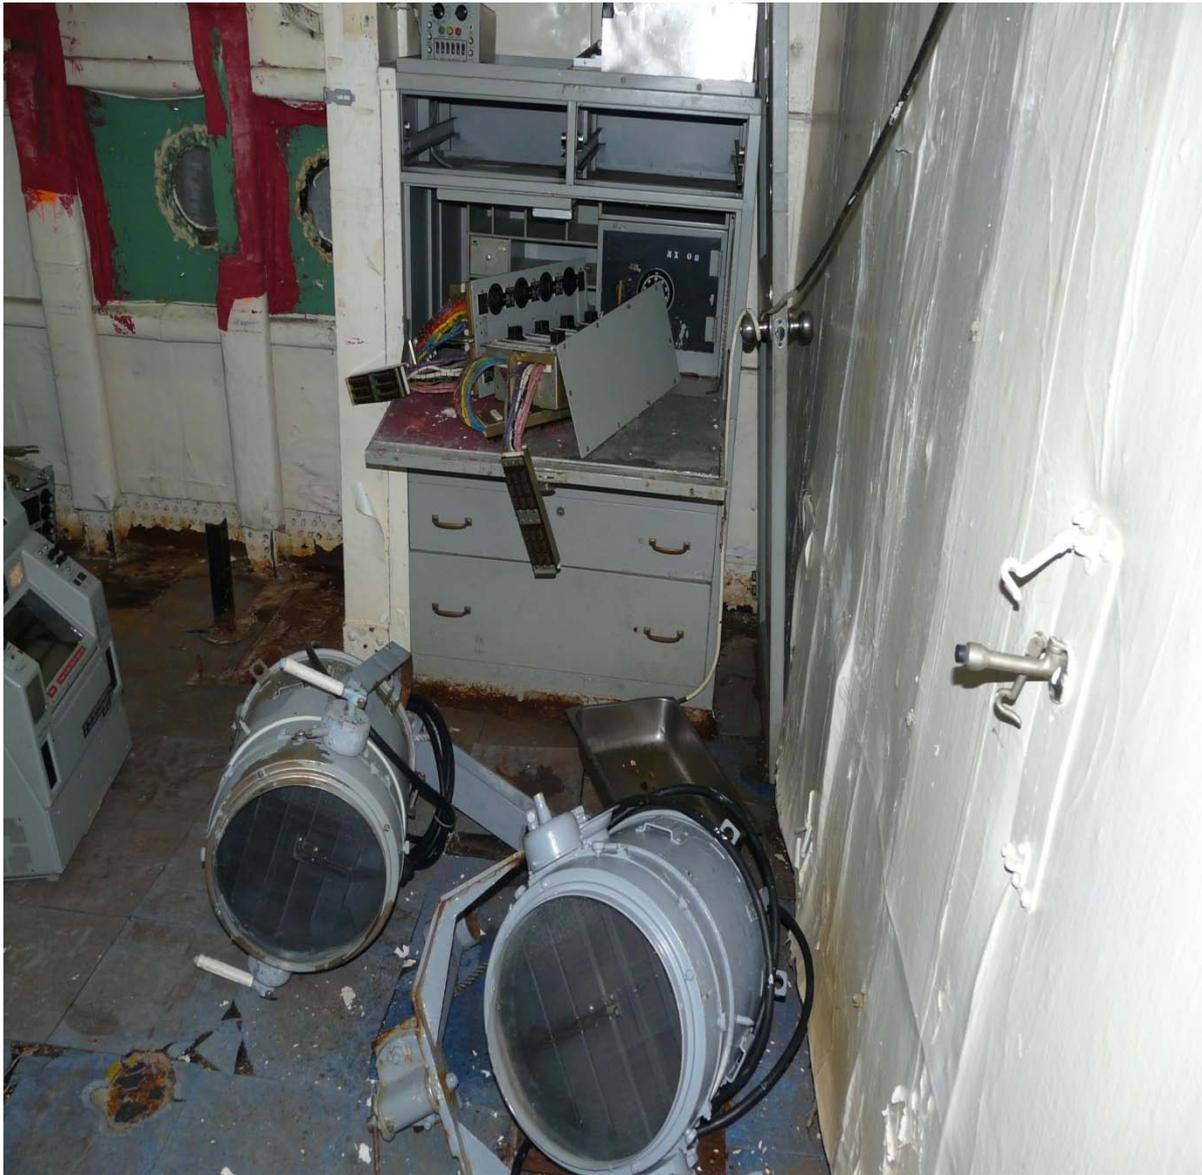
Office Space

Here are the two signal lights that were removed from the USNS Saturn during open house. This is one of those spaces that will need work done to repair the rust issues where the bulkhead meets the deck.

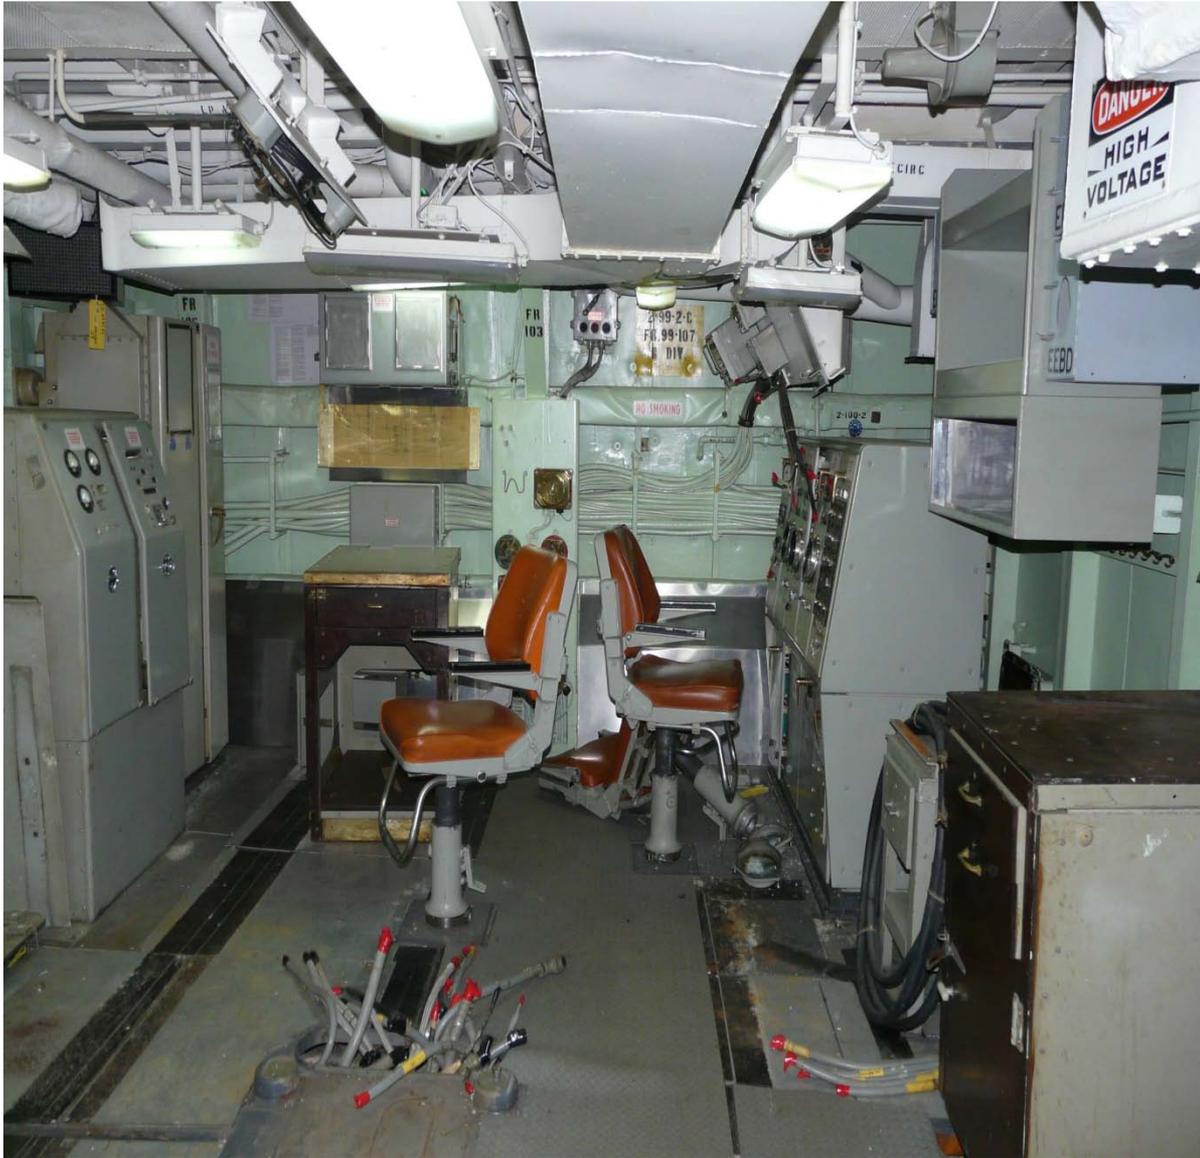
Gun Plot

Taken from the door looking in. As you can see, whatever equipment was mounted in the center of the compartment is missing. This is part of the digital upgrade Adams had. On other Adams Class ships a MK47 Analog Computer was mounted here and took up the entire center section of the compartment.

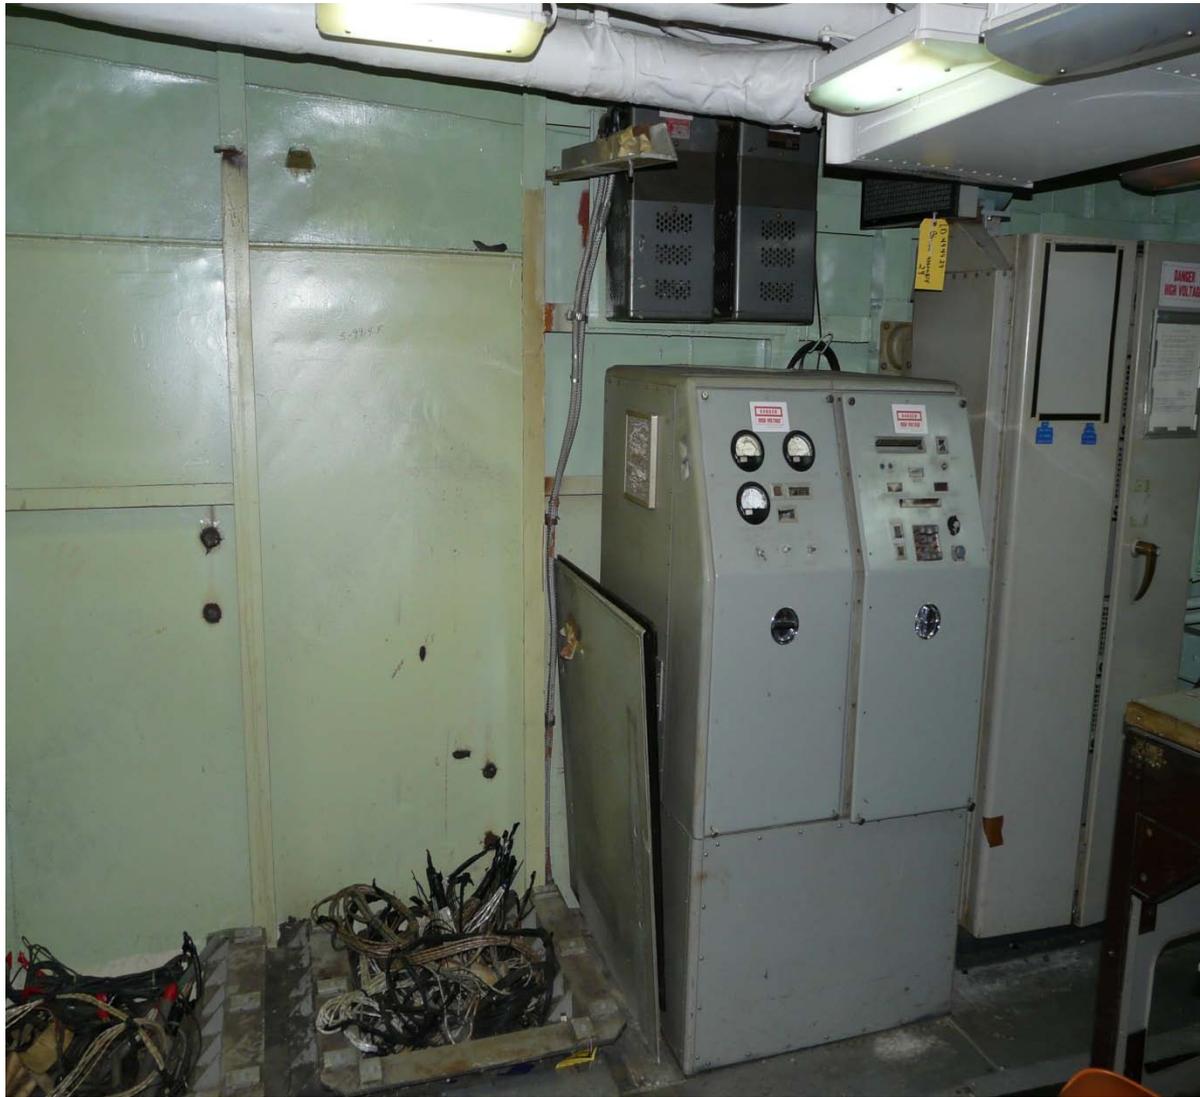
Gun Plot

Here is the aft bulkhead of Gun Plot. On the left you can see that the fire control switchboards are missing. We have identified the company that manufactures these and they are still making them. They also make a great deal of navy IC equipment.

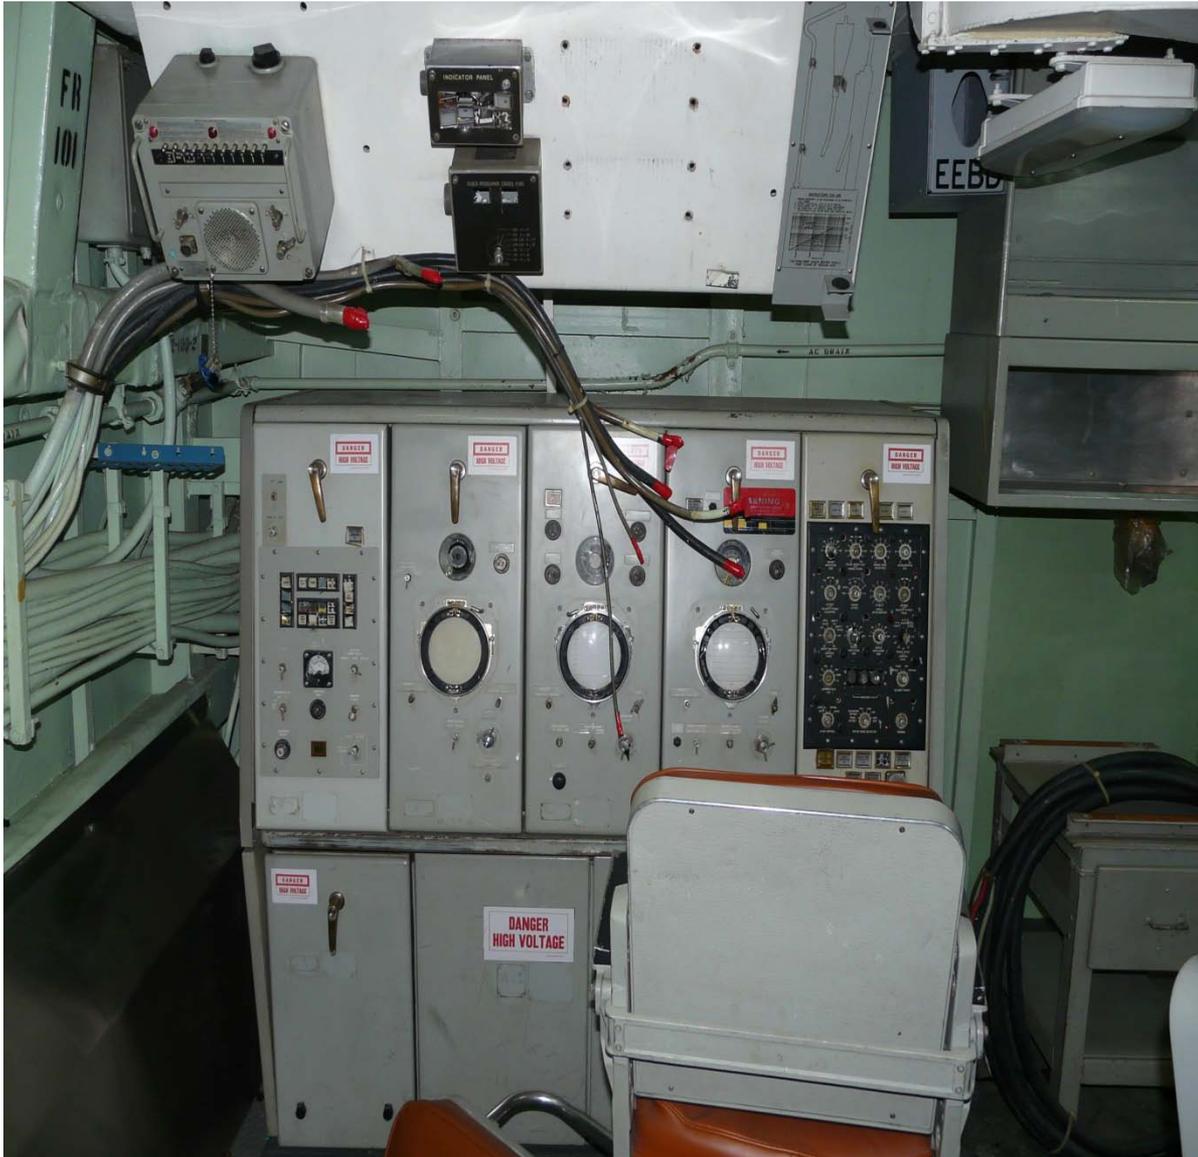
The AN/SPG-53F Radar is located in Gun Plot. The knobs and push buttons have been DEMILED as was the inside of the cabinet.
