USS Charles F Adams DDG-2 Philadelphia Open House

May 17-18, 2010

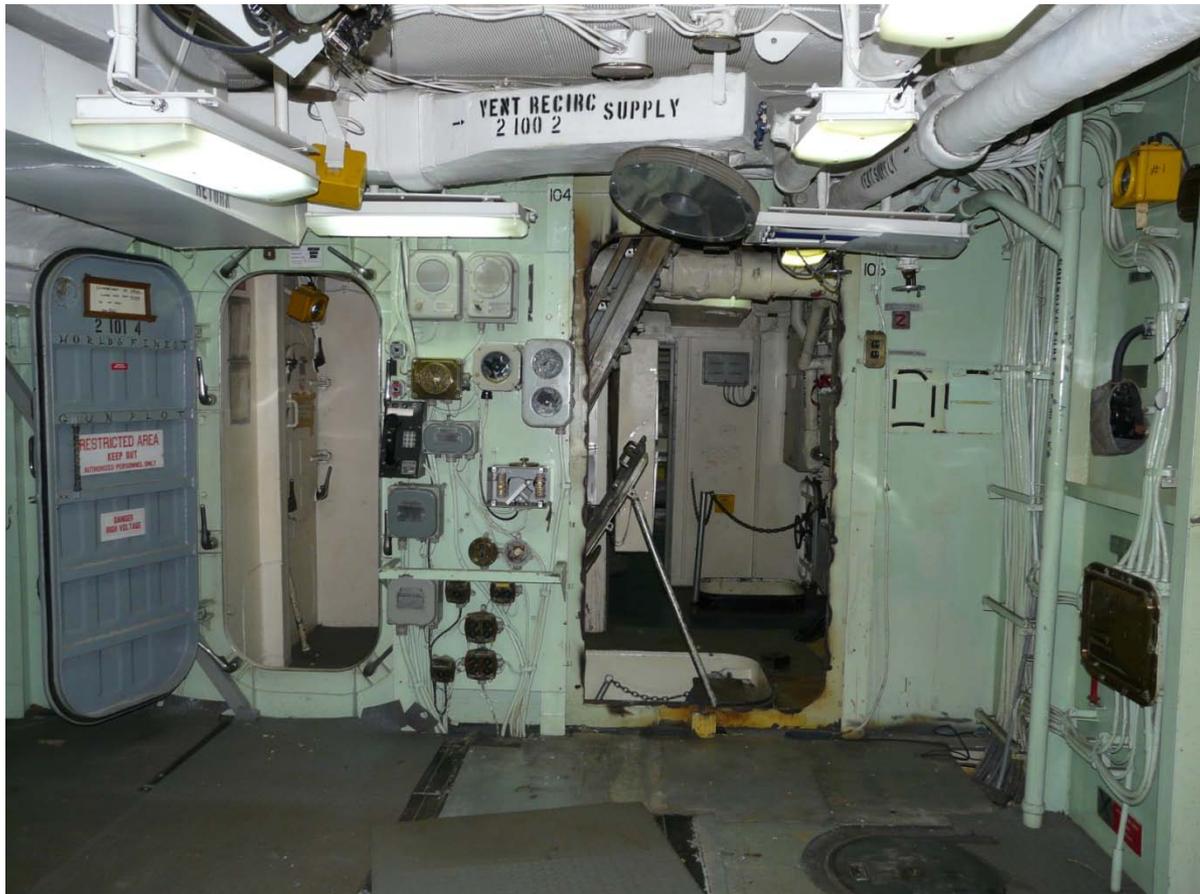
Gun Plot

Taken from the port side looking towards amidships. A section of the bulkhead was removed to remove equipment. That section of the bulkhead is still there in DC Central and needs welded back in place.

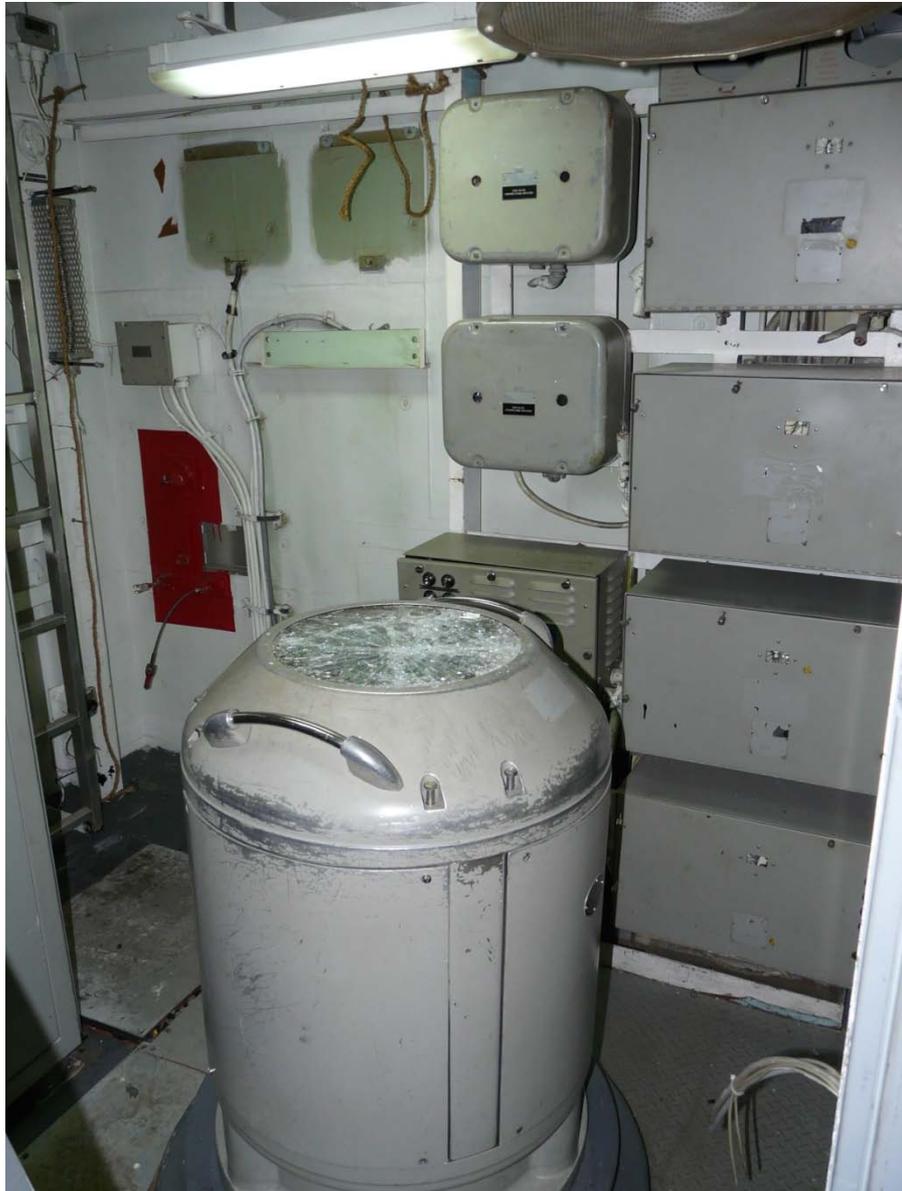
Ship's Gyro

Located at the bottom of the ladder and to the left in the IC Room. The glass was smashed on top of it but the indicators under the smashed glass were not damaged.

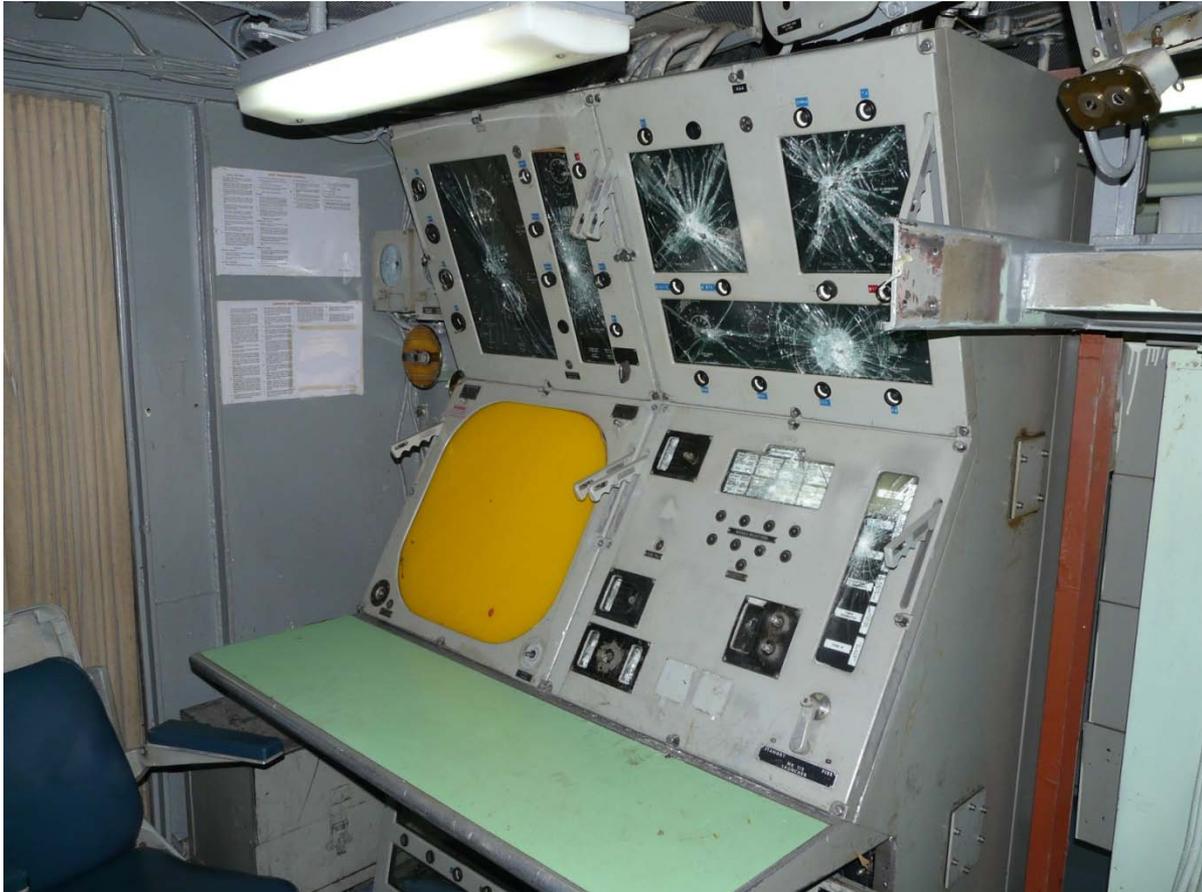
Sonar Room

DEMILED Sonar Console.

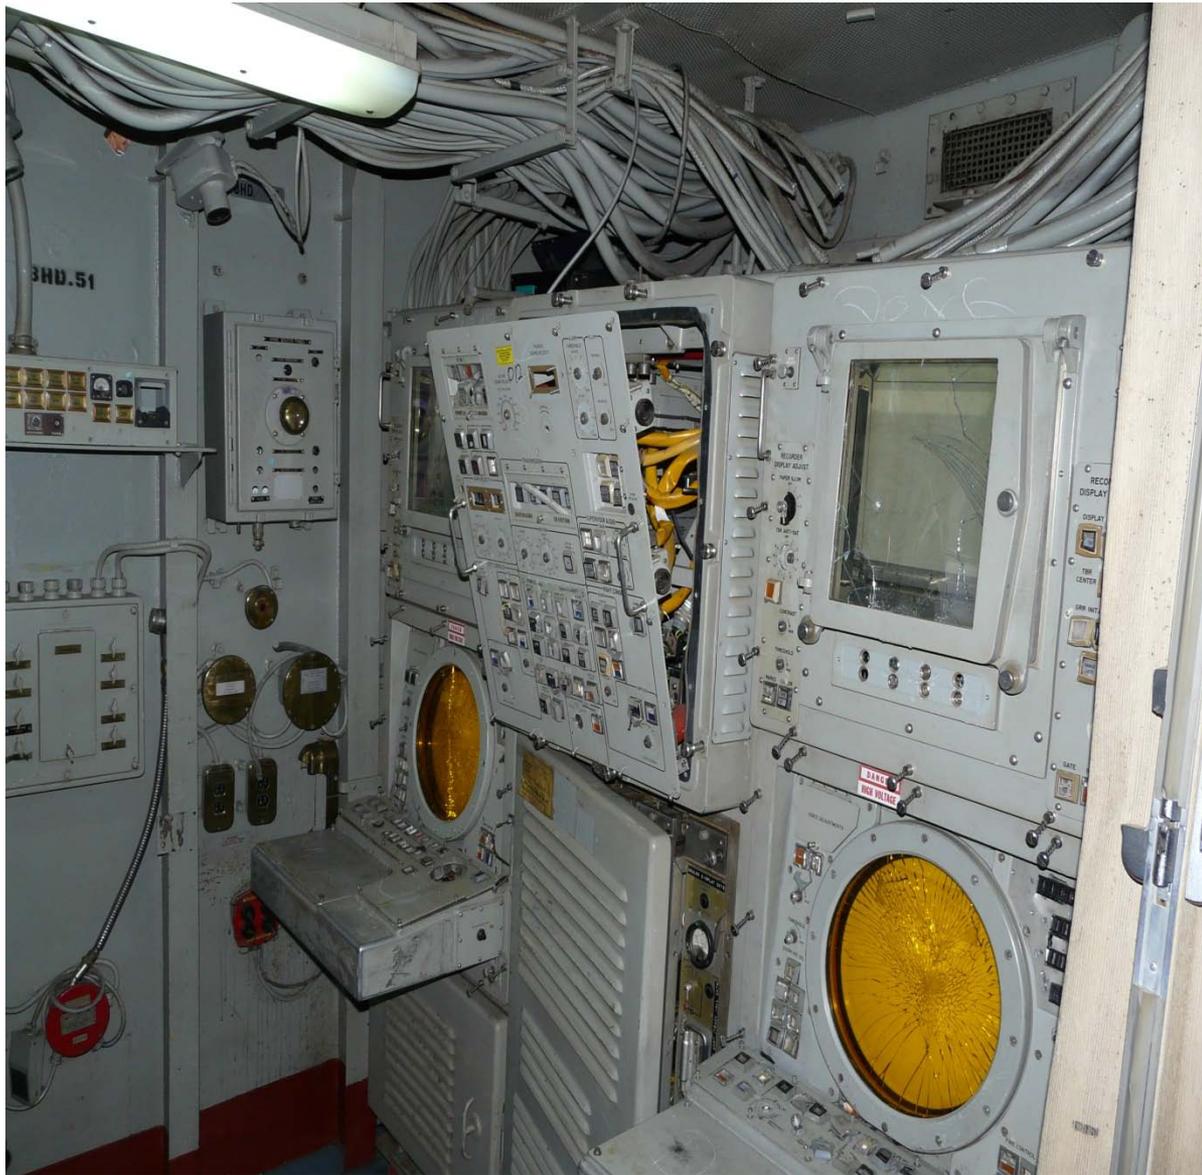
Sonar Room

Additional sonar consoles also DEMILED, but outer glass on scopes the only thing broken. Easily replaced.

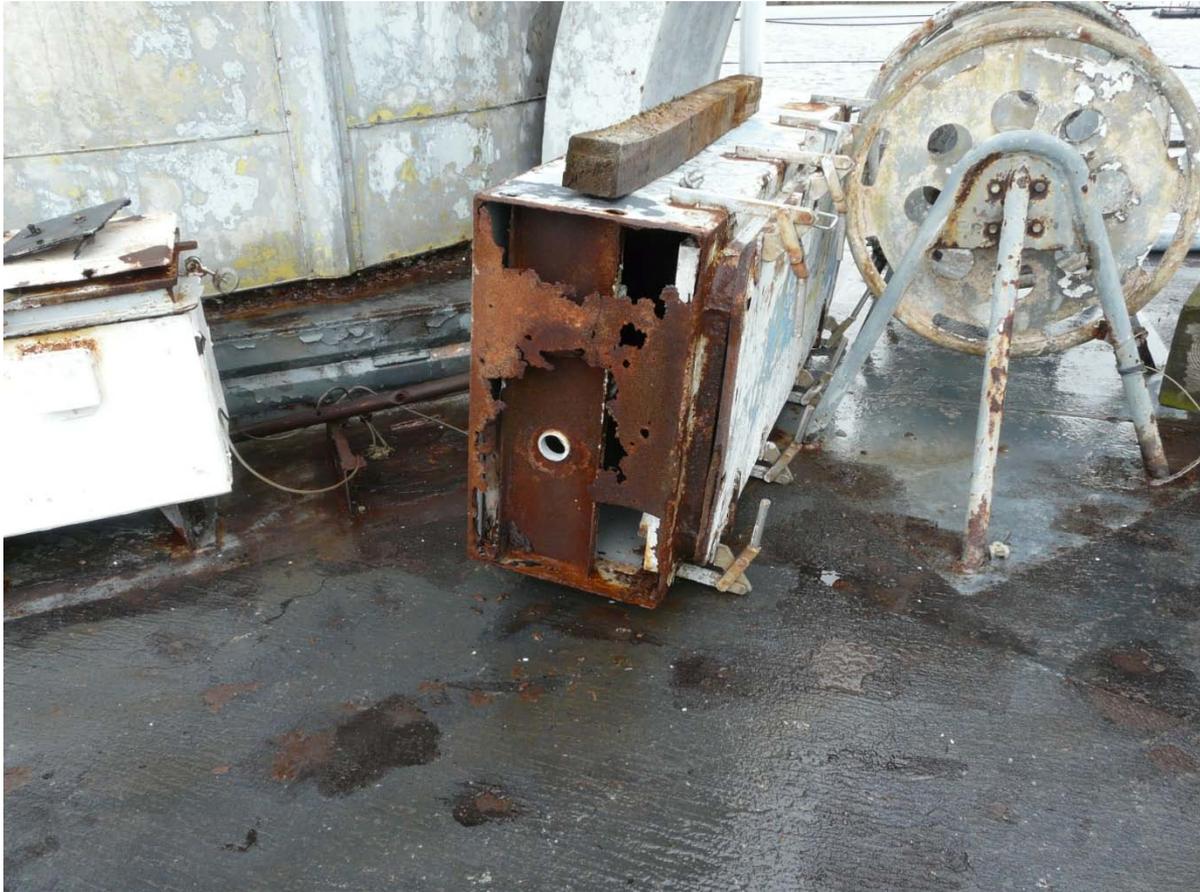
The cause of running rust.

All over the various decks are deck storage boxes, line reels, pipe fittings, sound powered phone boxes, and so on made out of steel. These items are rusting and causing running rust which drains over the side of the ship when it rains. These are the rust stains you see on the hull. The hull itself isn't rusting above the waterline. All the items mentioned above will be removed to get rid of deck clutter and safety hazards.

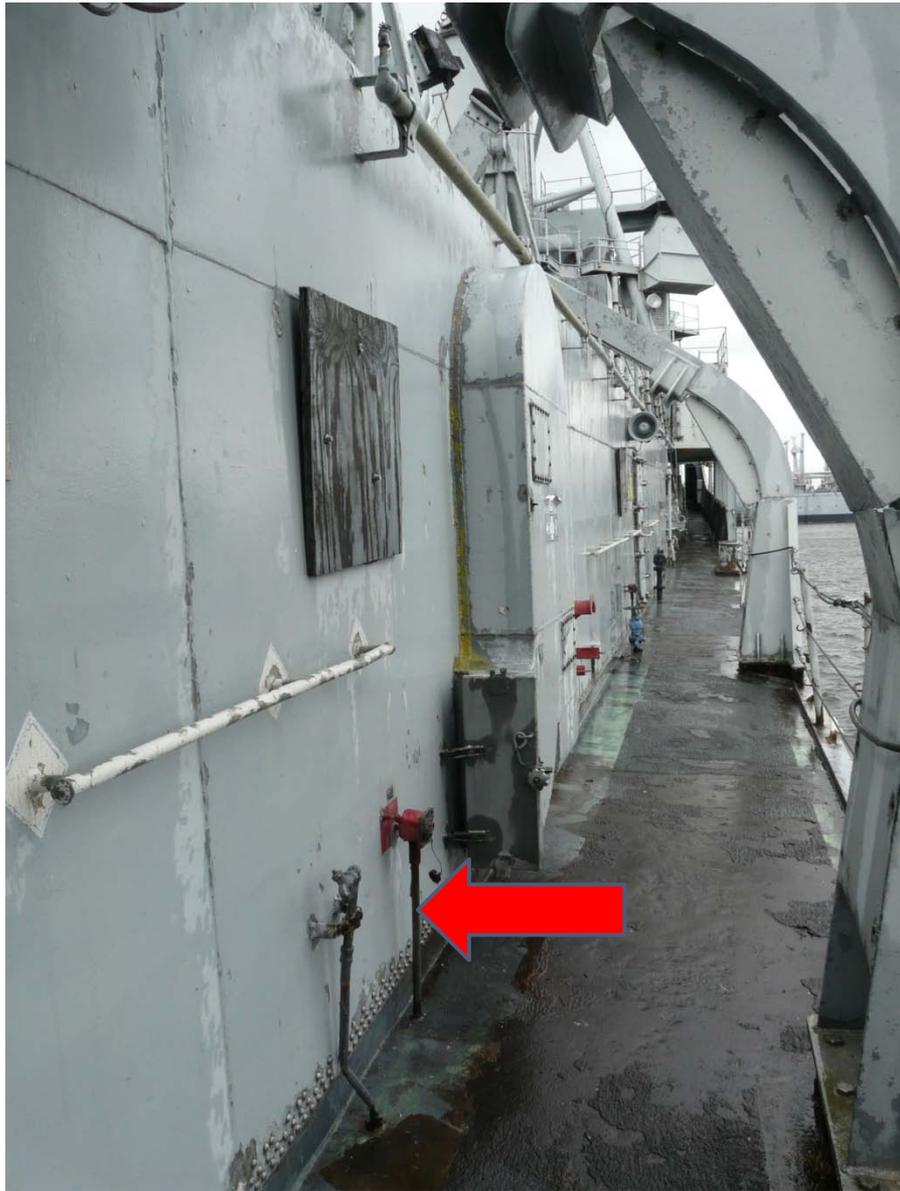
Main Deck

Main deck starboard looking forward. Items such as those where the red arrow points are items that will be removed and will help reduce over all maintenance.

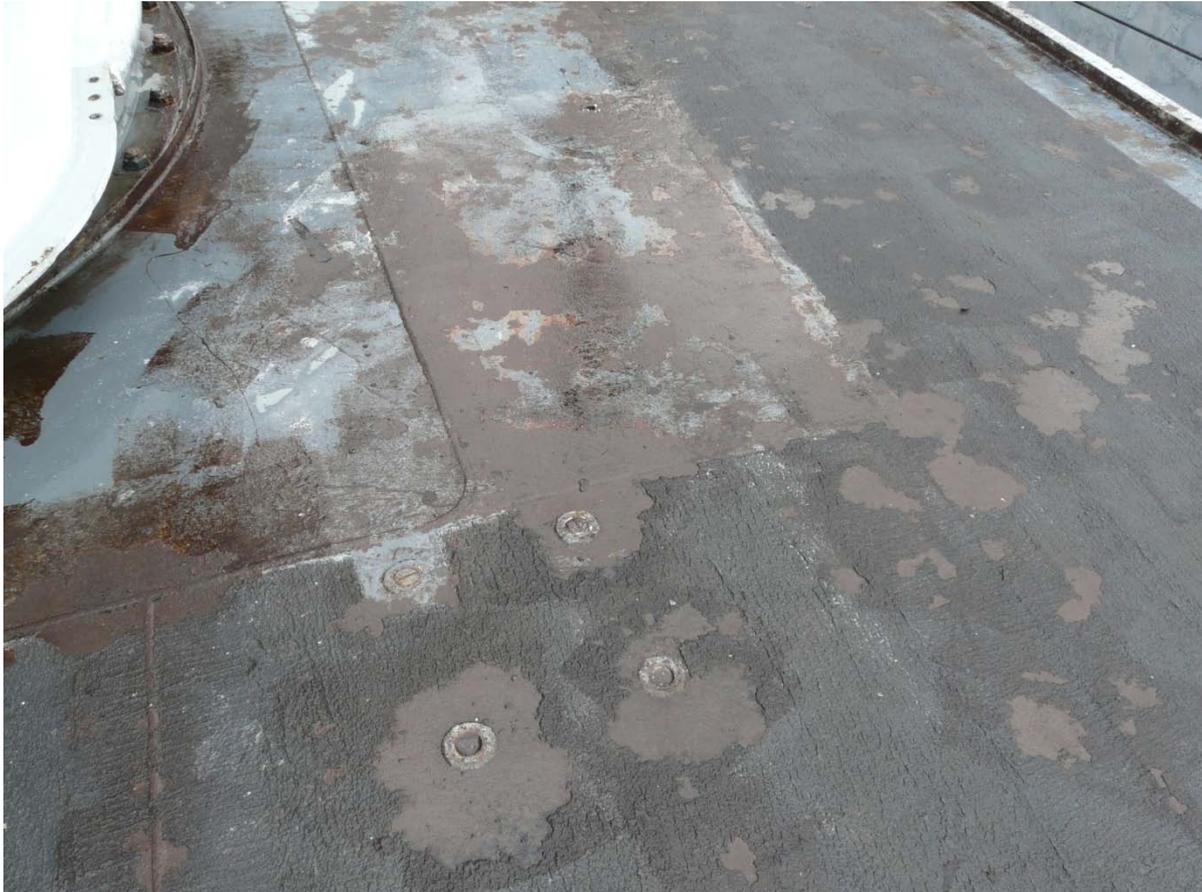
The Deck

Here is a photo of the deck itself taken near gun mount 51. Take note that you see that over the last 20 years non skid has flaked off.

There is a clear coat of a preservative that is made for steel on the entire main deck. This has prevented the deck from deteriorating.

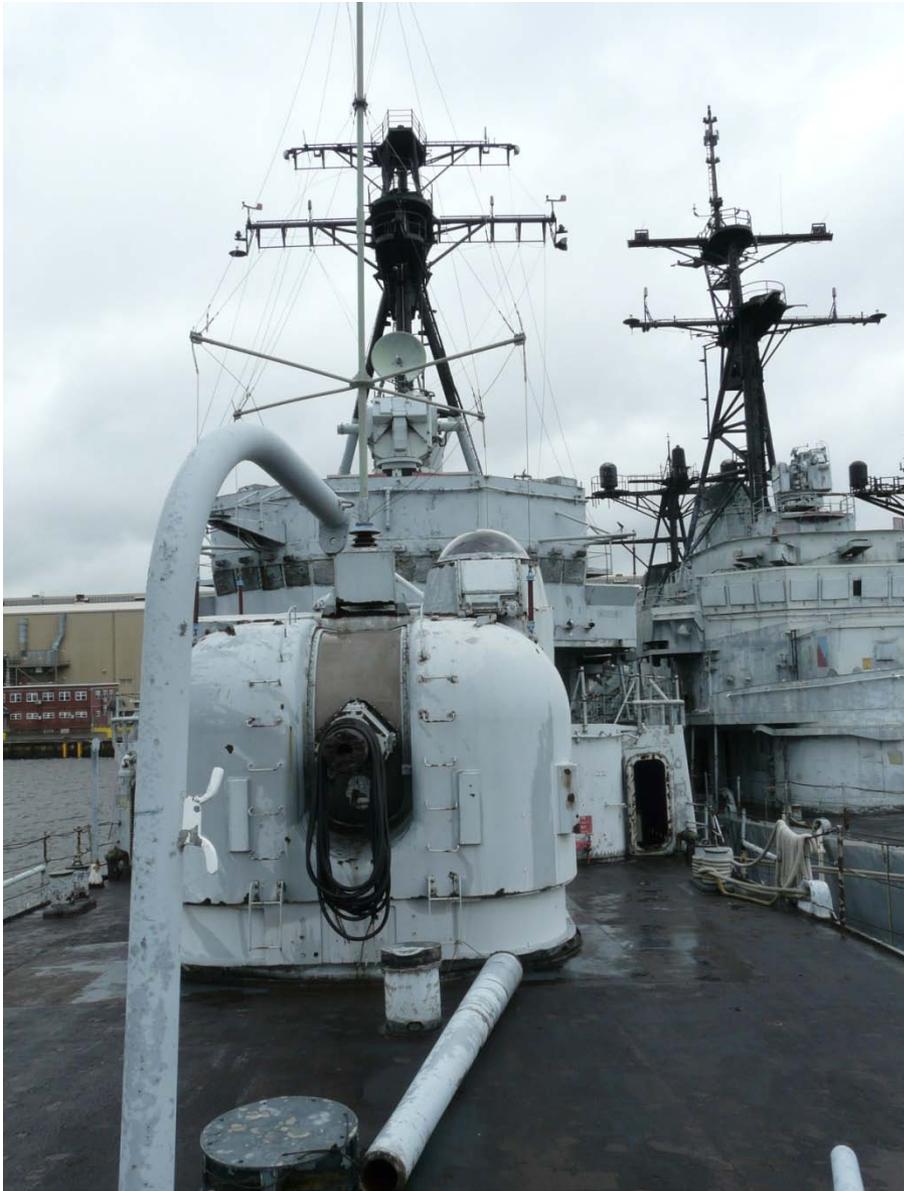
Main Deck

This is the main deck forward looking aft. The gun barrels from both guns have been cut off and welded to the deck..The antenna is still on top of MT 51.

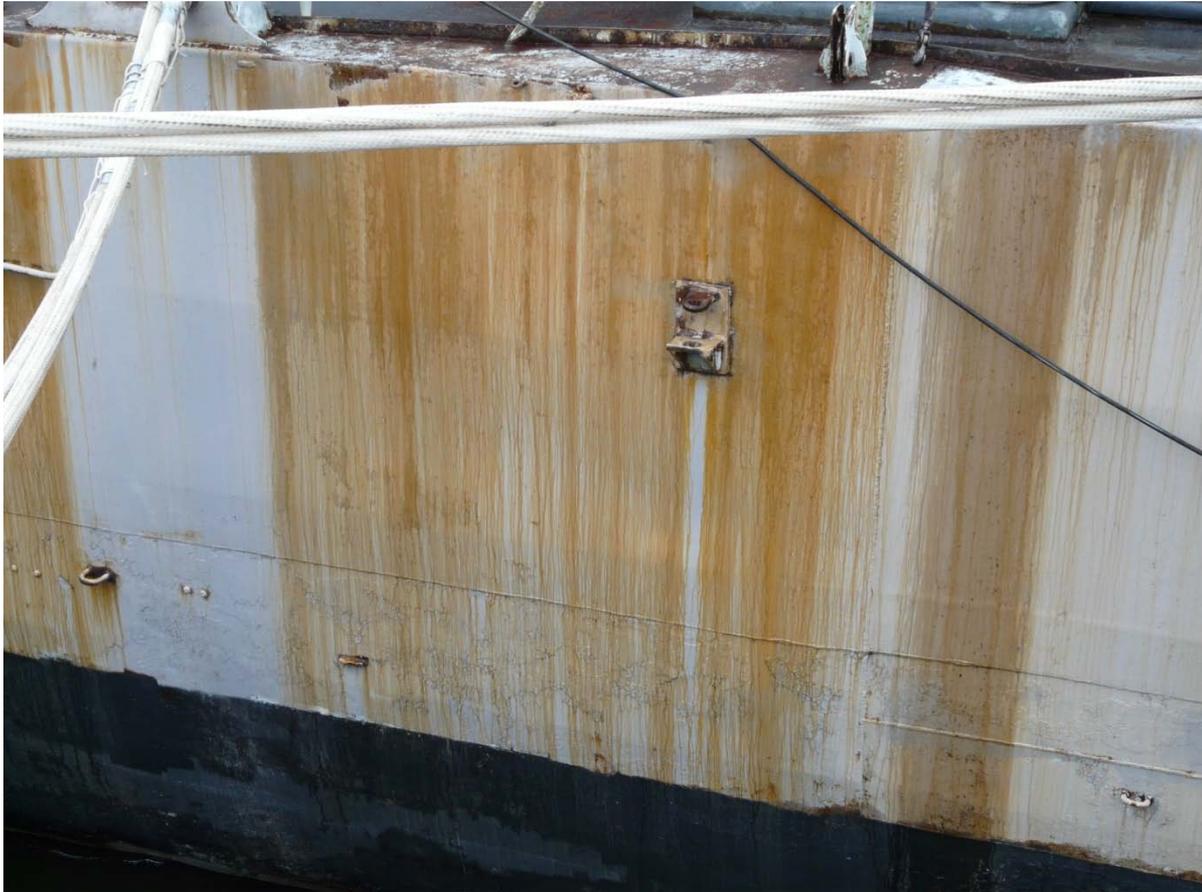
Port Hull Aft

Here is a picture of the hull with the rust stains. These are rust stains from the rusted out items like the deck boxes as shown on other slides. The paint job done two years ago has held up very well and isn't flaking or rusting..

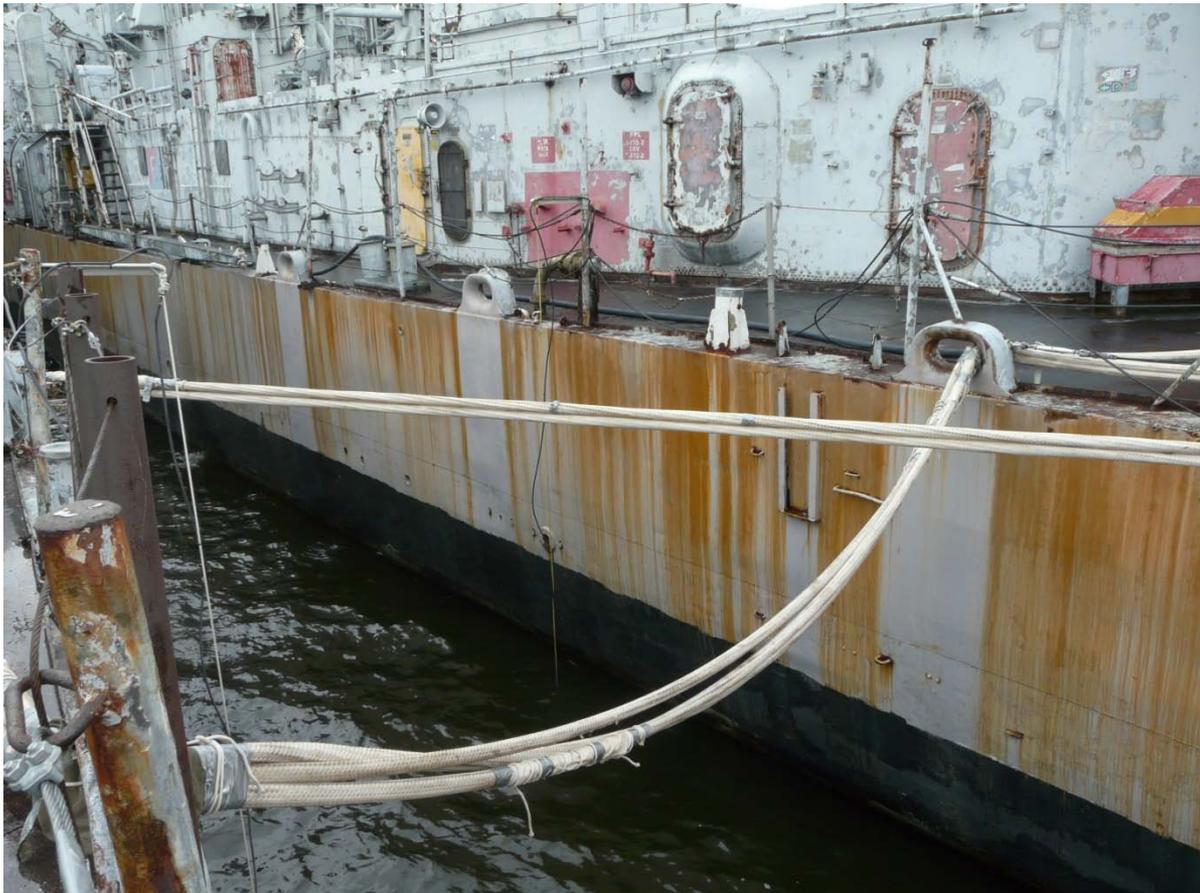
Port Side Aft

Another picture to show the rust stains coming from the run off on the main deck when it rains. Also note the aluminum bulkhead. The issue here is just flaking paint.
