USS Charles F Adams DDG-2 Philadelphia Open House

May 17-18, 2010

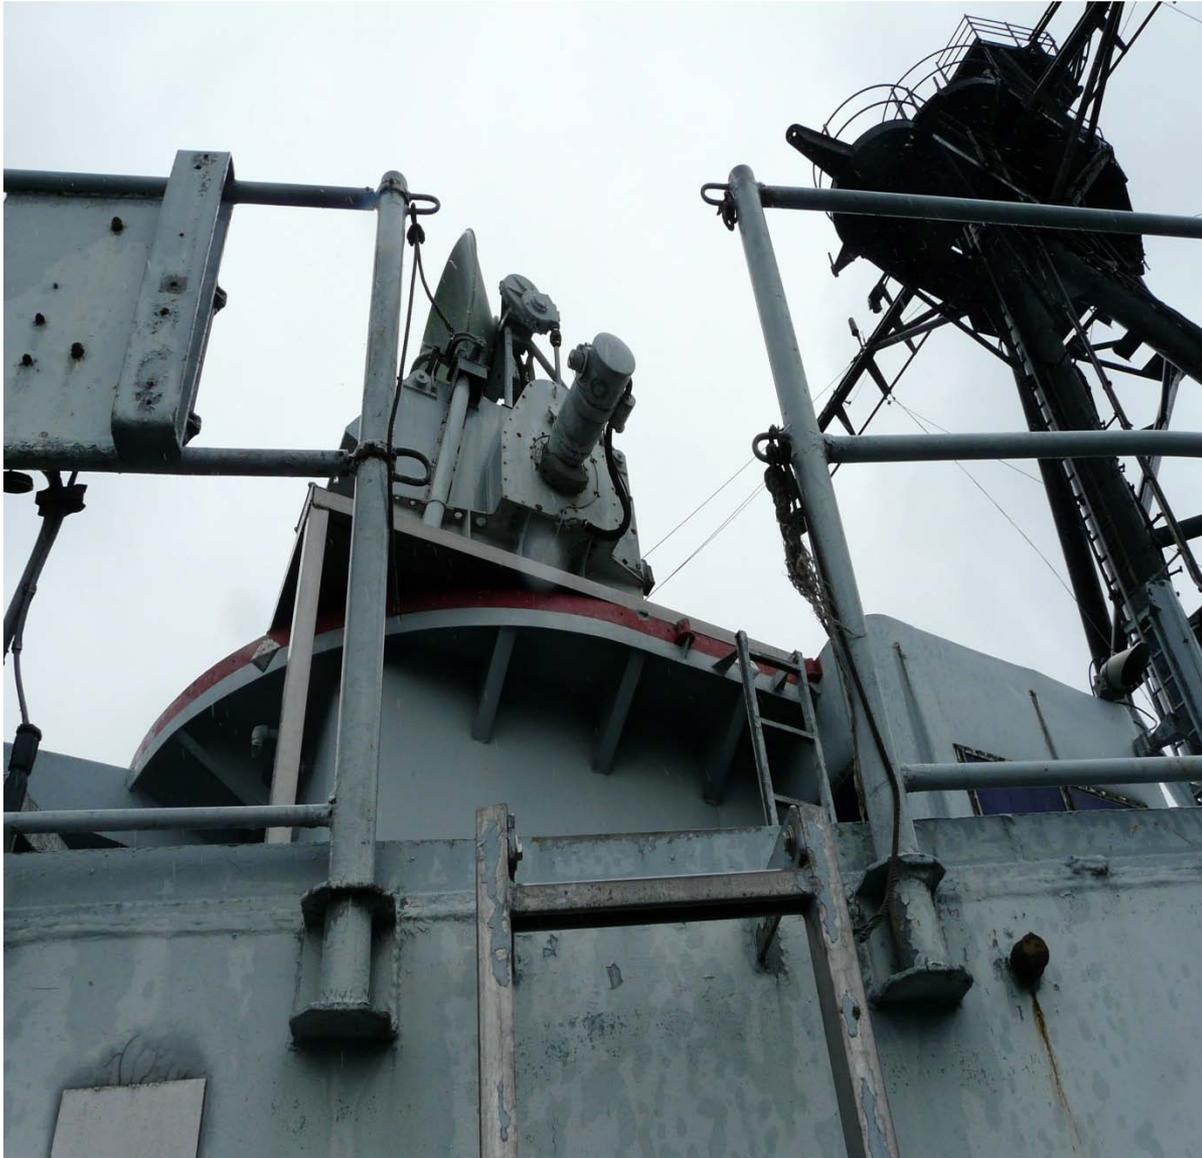
Bridge Wing Port Side

This was taken on the port side bridge wing looking up. Here you see the MK 68 Gun Director and the main mast.

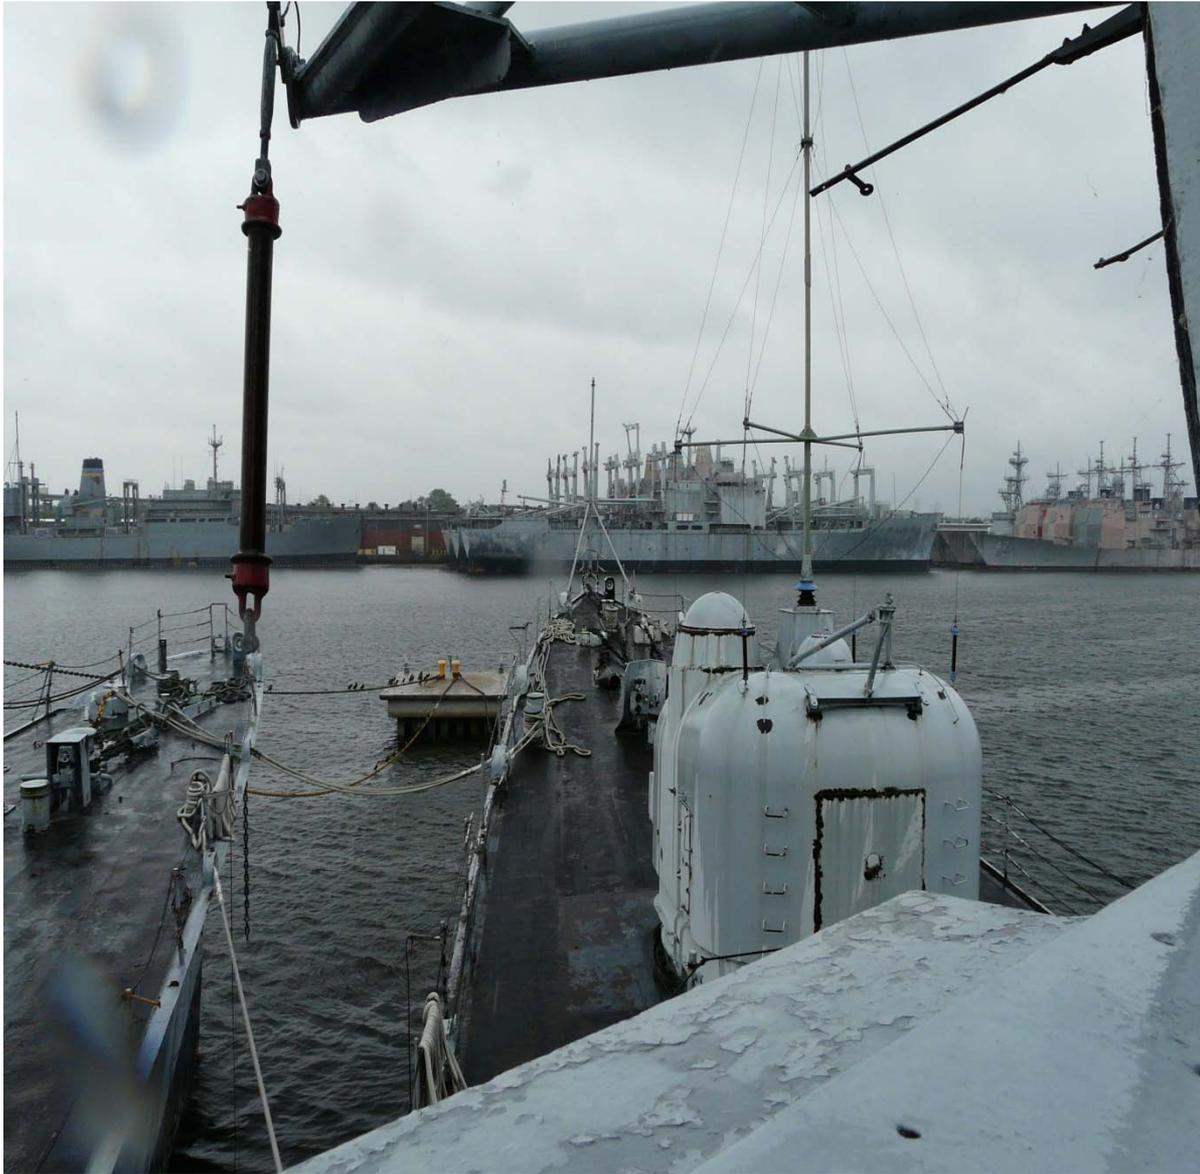
Port Bridge Wing looking forward

Note the antenna that is still on the gun mount. The ships on the right in the distance are the Aegis Cruisers where we removed equipment. The ship on the right is the USNS Saturn where we got the signal lights and fire main fittings. If you look at the main deck, a good deal of the non skid surface appears to remain intact.

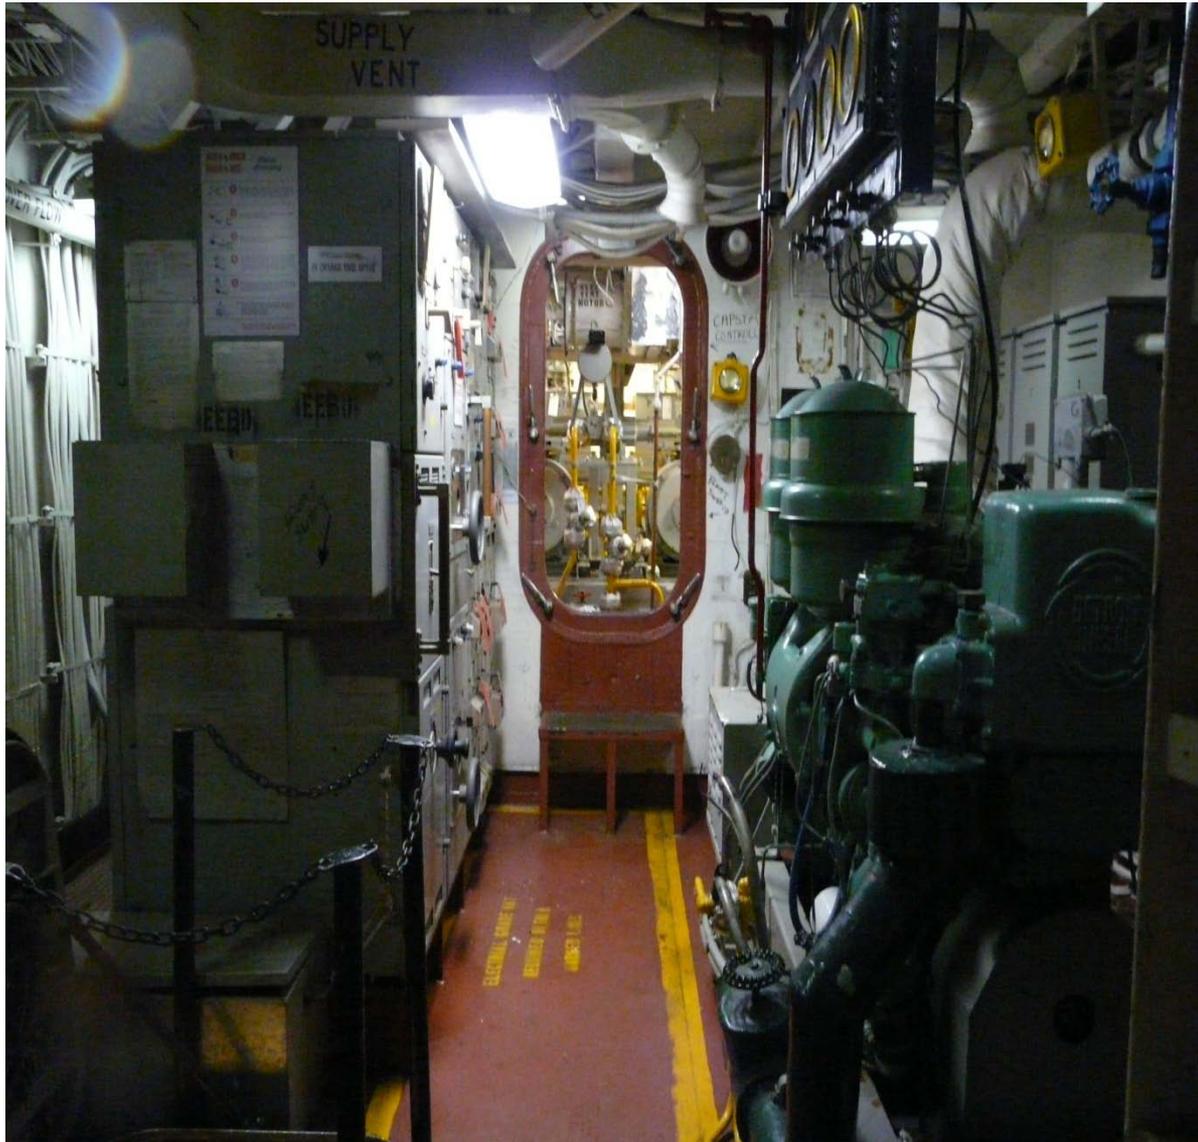
After Diesel

The entrance to after diesel looking aft into after steering. The generator and switchboard on the left appear to be intact.

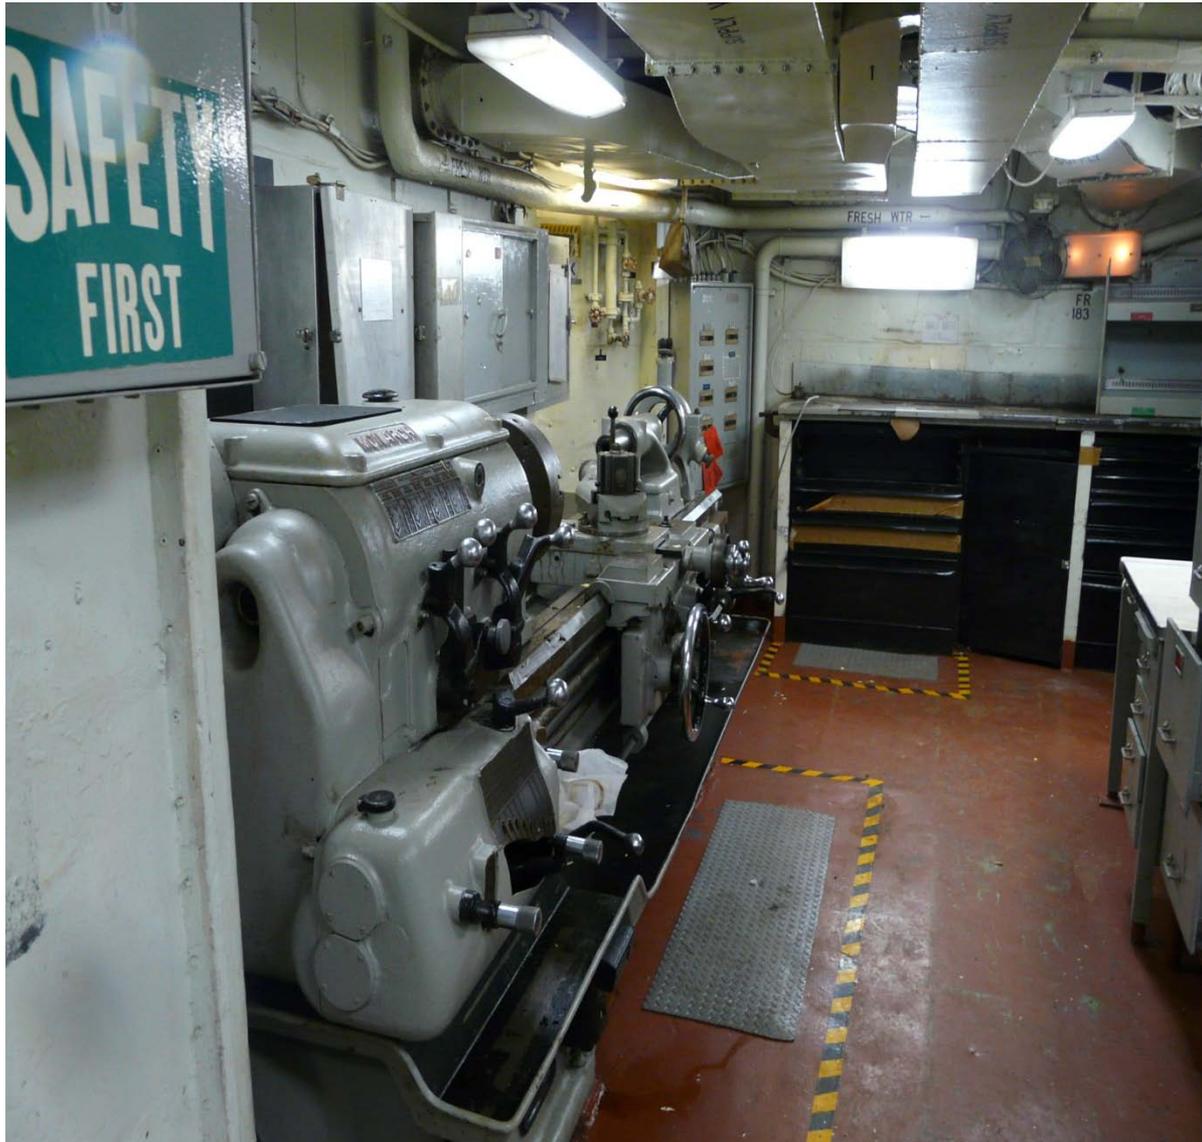
Machine Shop starboard side aft

Lathe on left is intact and there is other equipment located in the space.

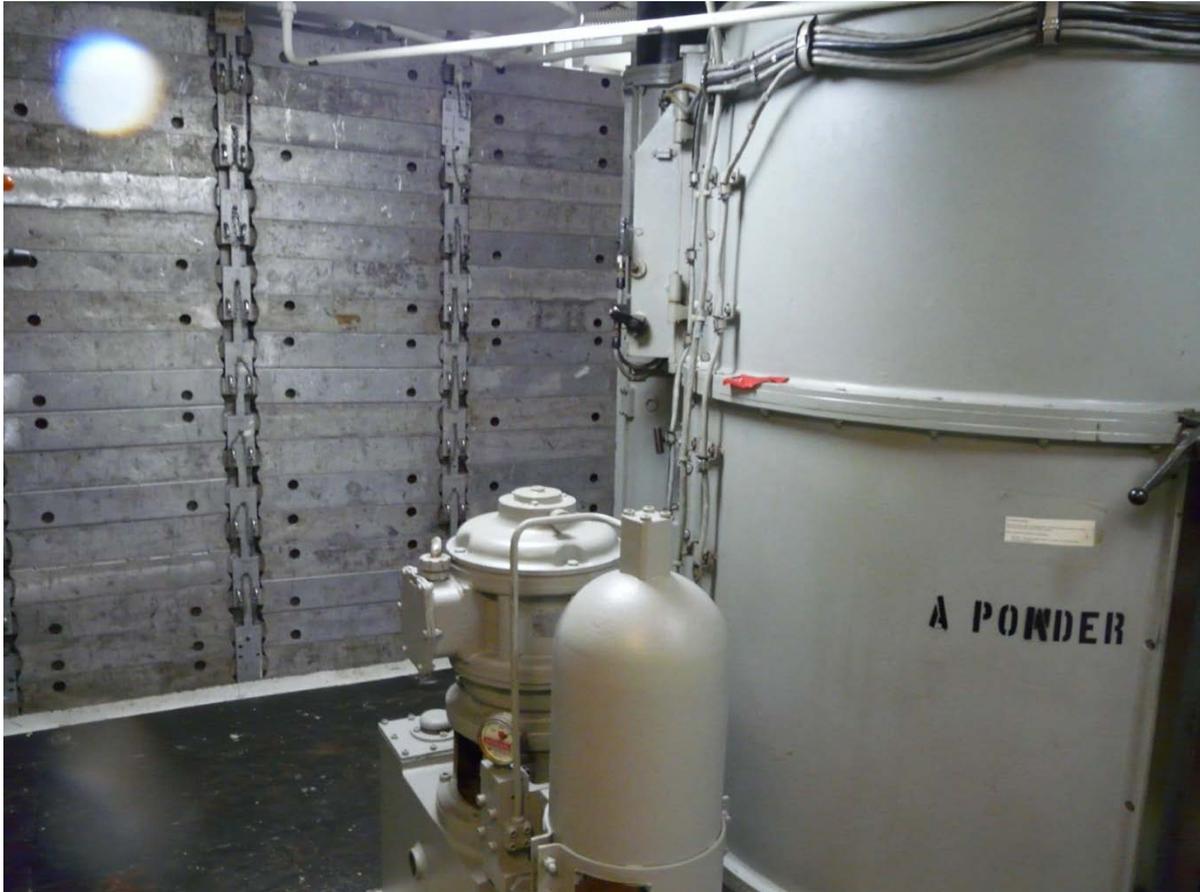
MT 52 Magazine

Here are the ammunition loader drums for the after gun mount in the magazine. All powder and “bullet” racks are still present and no DEMILING has taken place here. There was no water infiltration anywhere here in one of the lowest sections of the ship. This most likely will not be one of the areas that will ever be open to the general public due to its difficulty in getting down the vertical ladders.

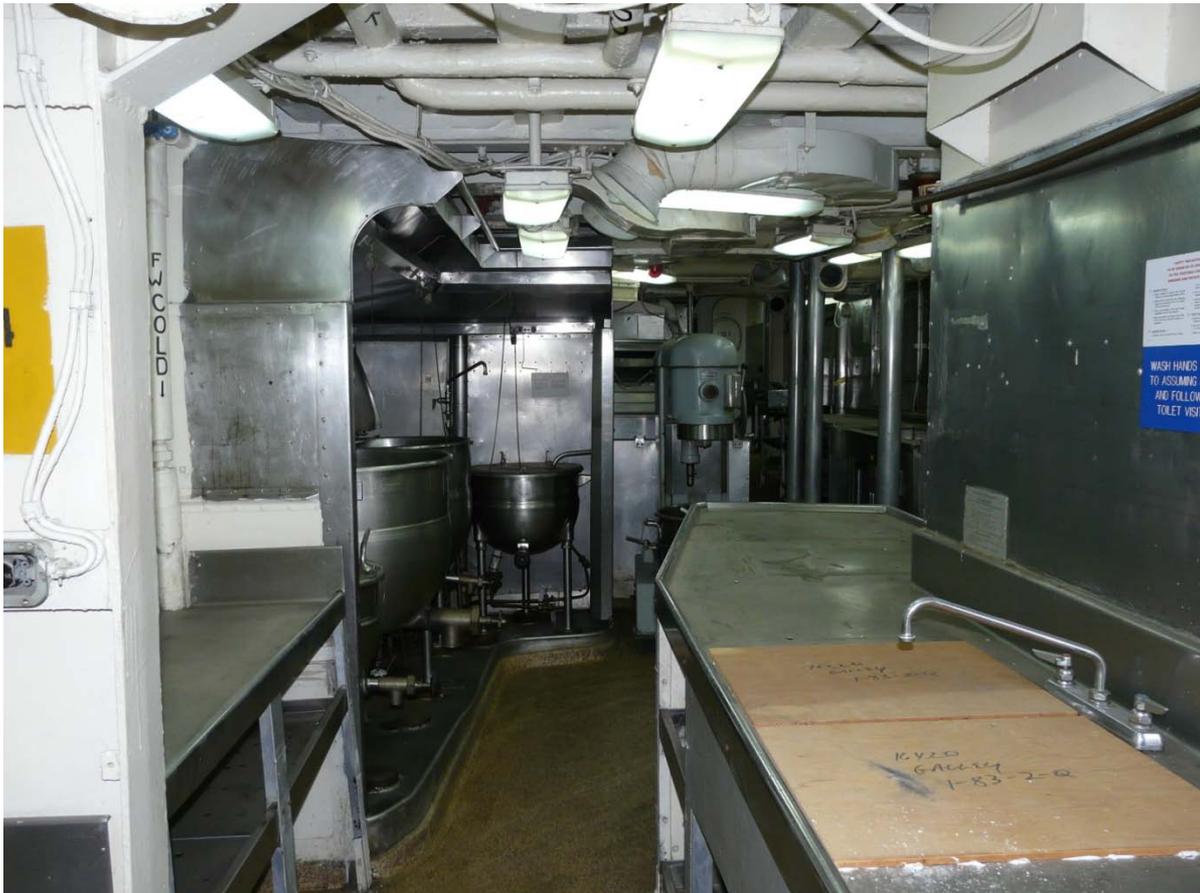
This photo was taken from aft looking forward. The Galley is pretty much intact.

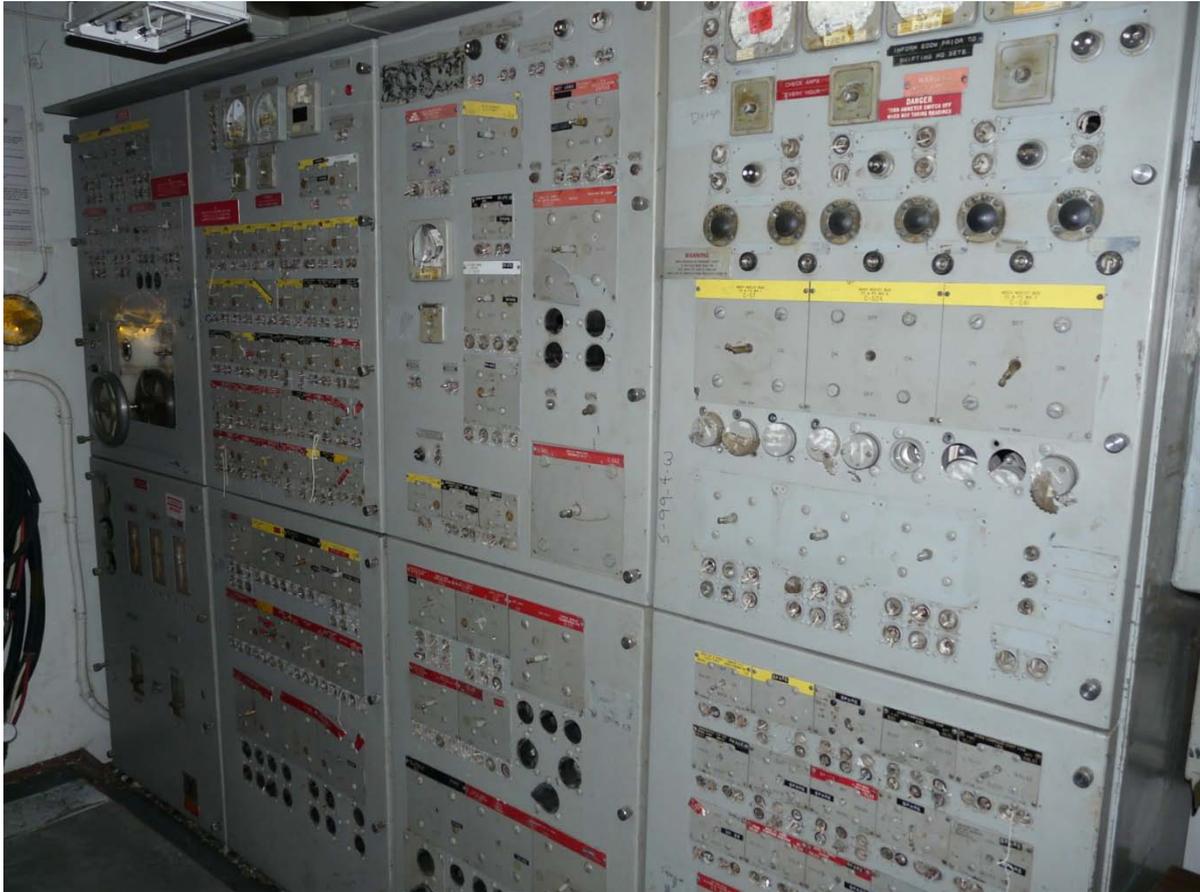
Here is the IC Switchboard in the IC Room which is two decks down from the Mess Decks. It also has been DEMILED with the fuses and switches busted off.

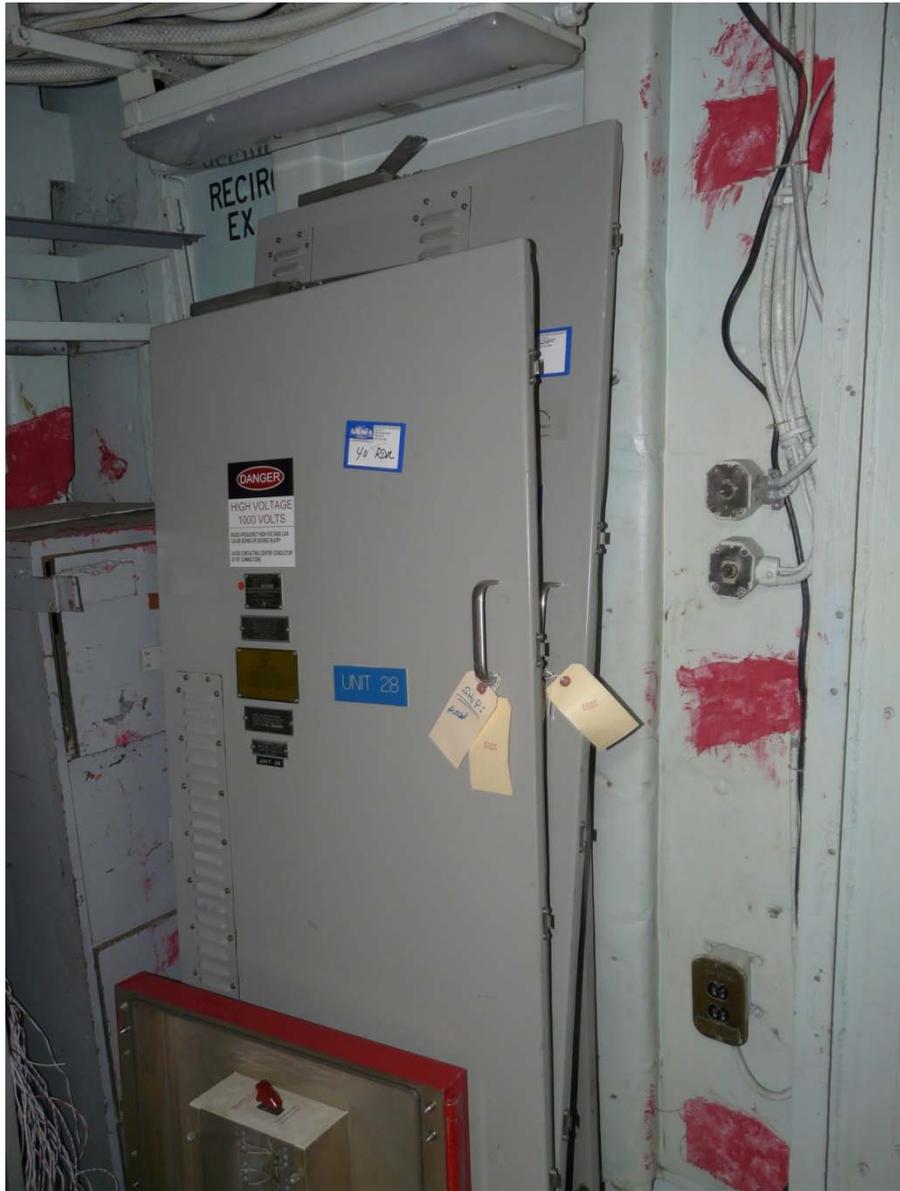
40 Radar Room

These are doors off the 40 radar cabinets. That were removed from the USS Austin. The cabinets were too large to remove so each cabinet was measured and will be built out plywood and covered with sheet metal with its door reattached.

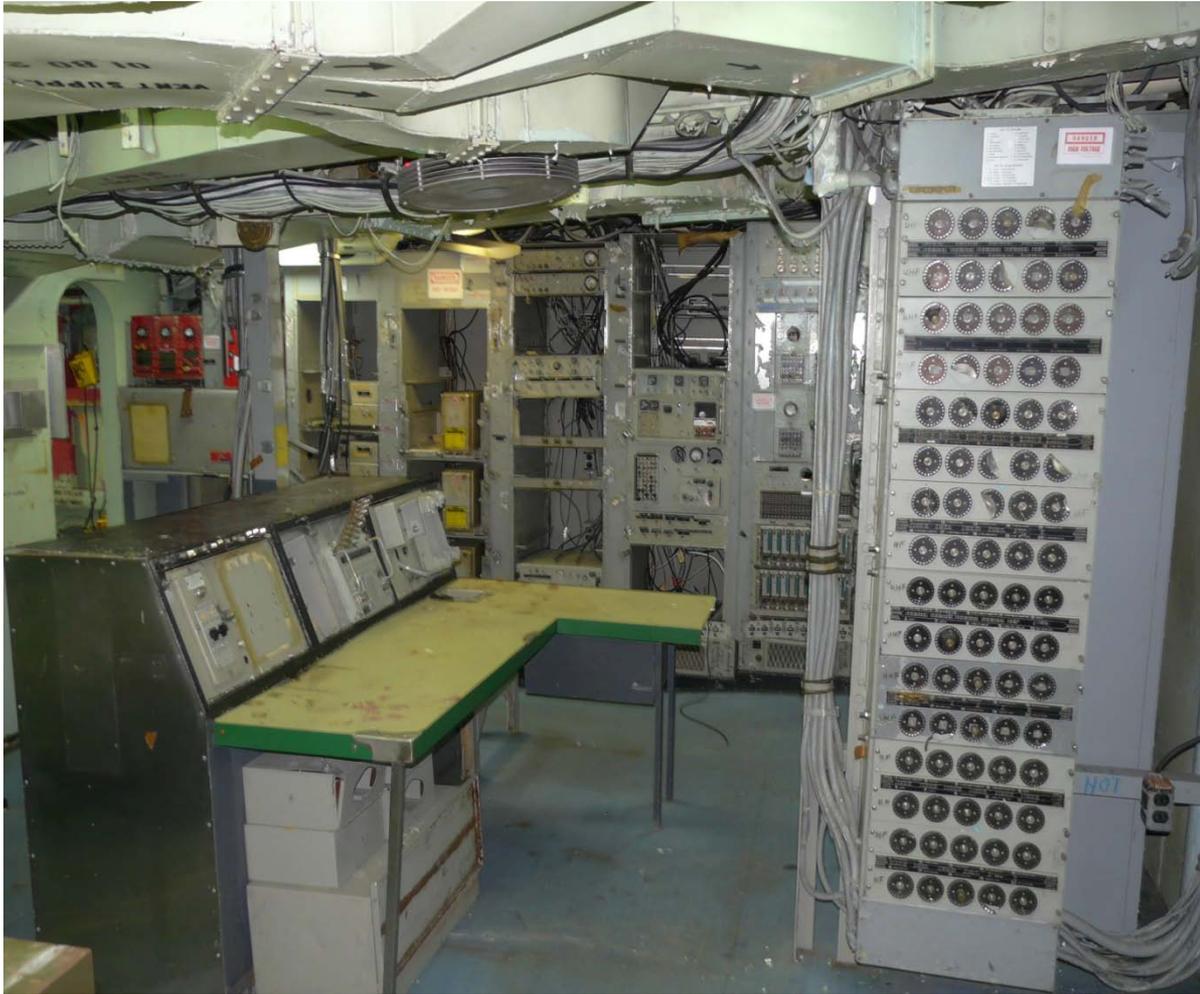
Radio Central

This was taken from the passageway looking through the doorway. Notice all the missing equipment in the racks. This is where all the radio equipment we have obtained from the open house will go.

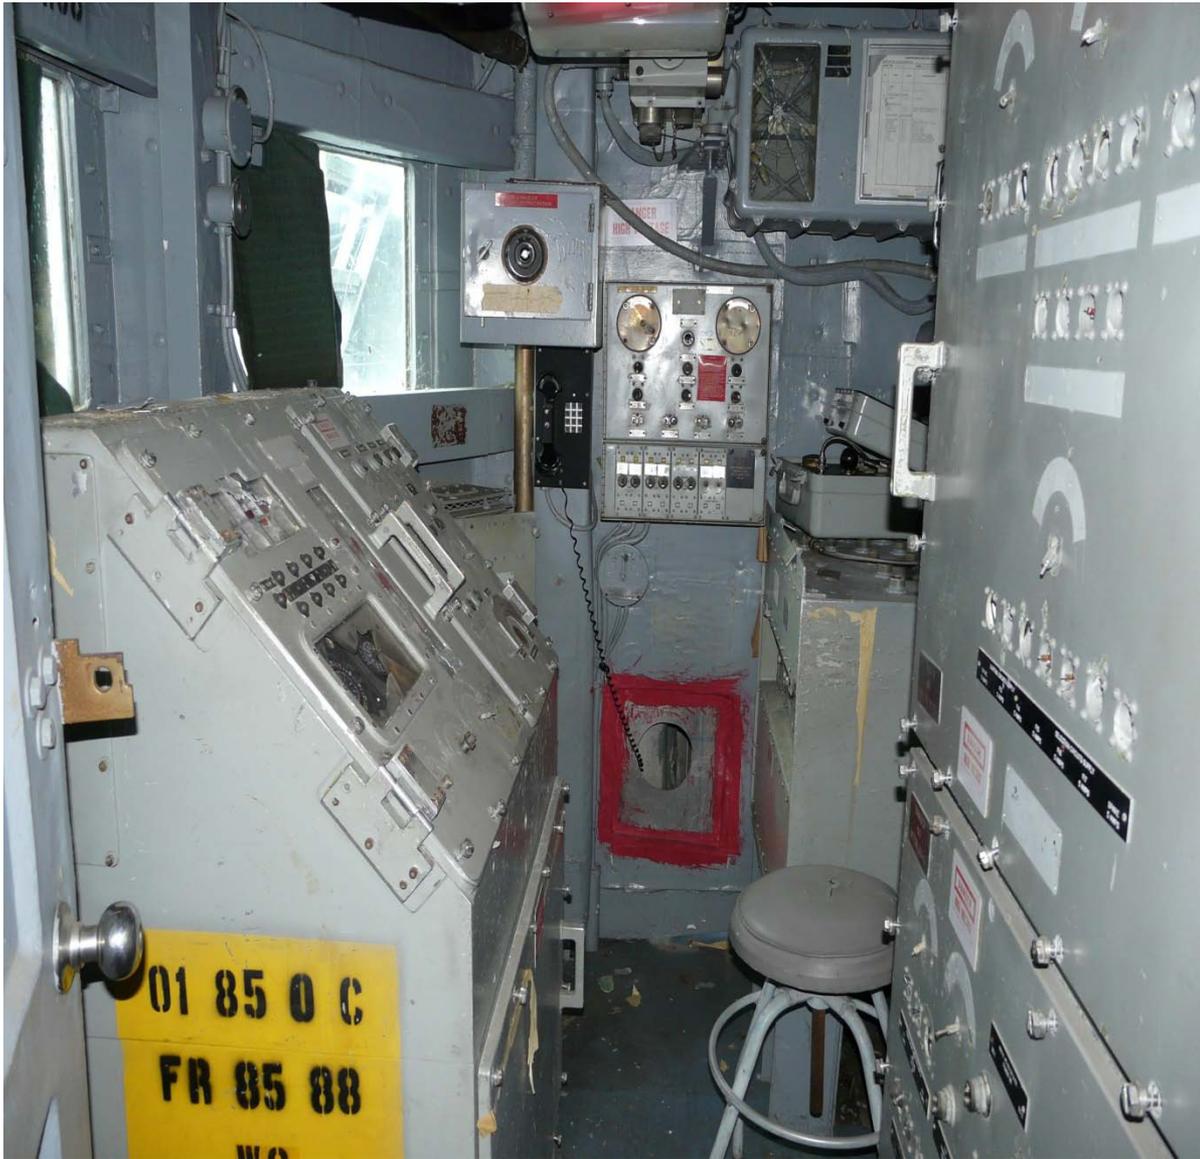
ASROC Launcher Control

This is forward of the ASROC Launcher. Looking out the windows you can see the ASROC Launcher. This space has been DEMILED.

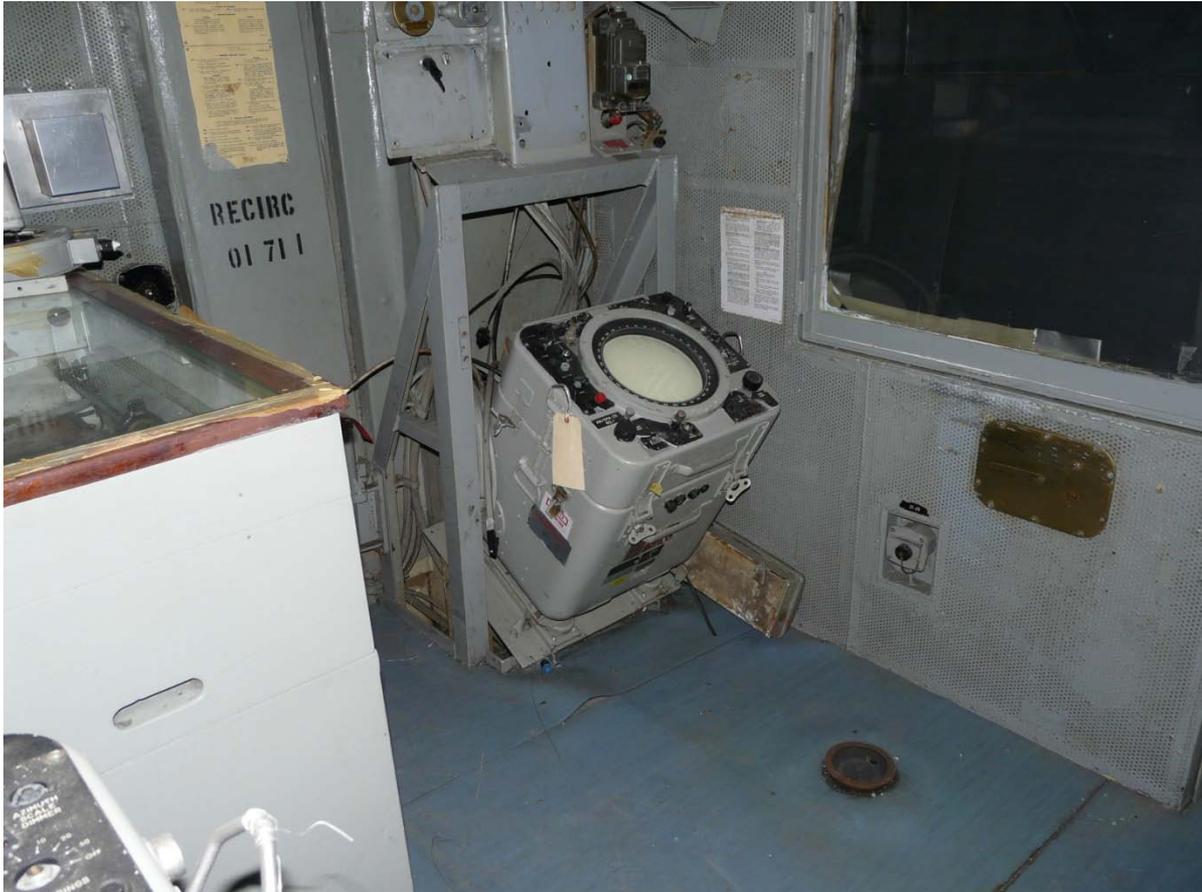
CIC

Aft looking forward.

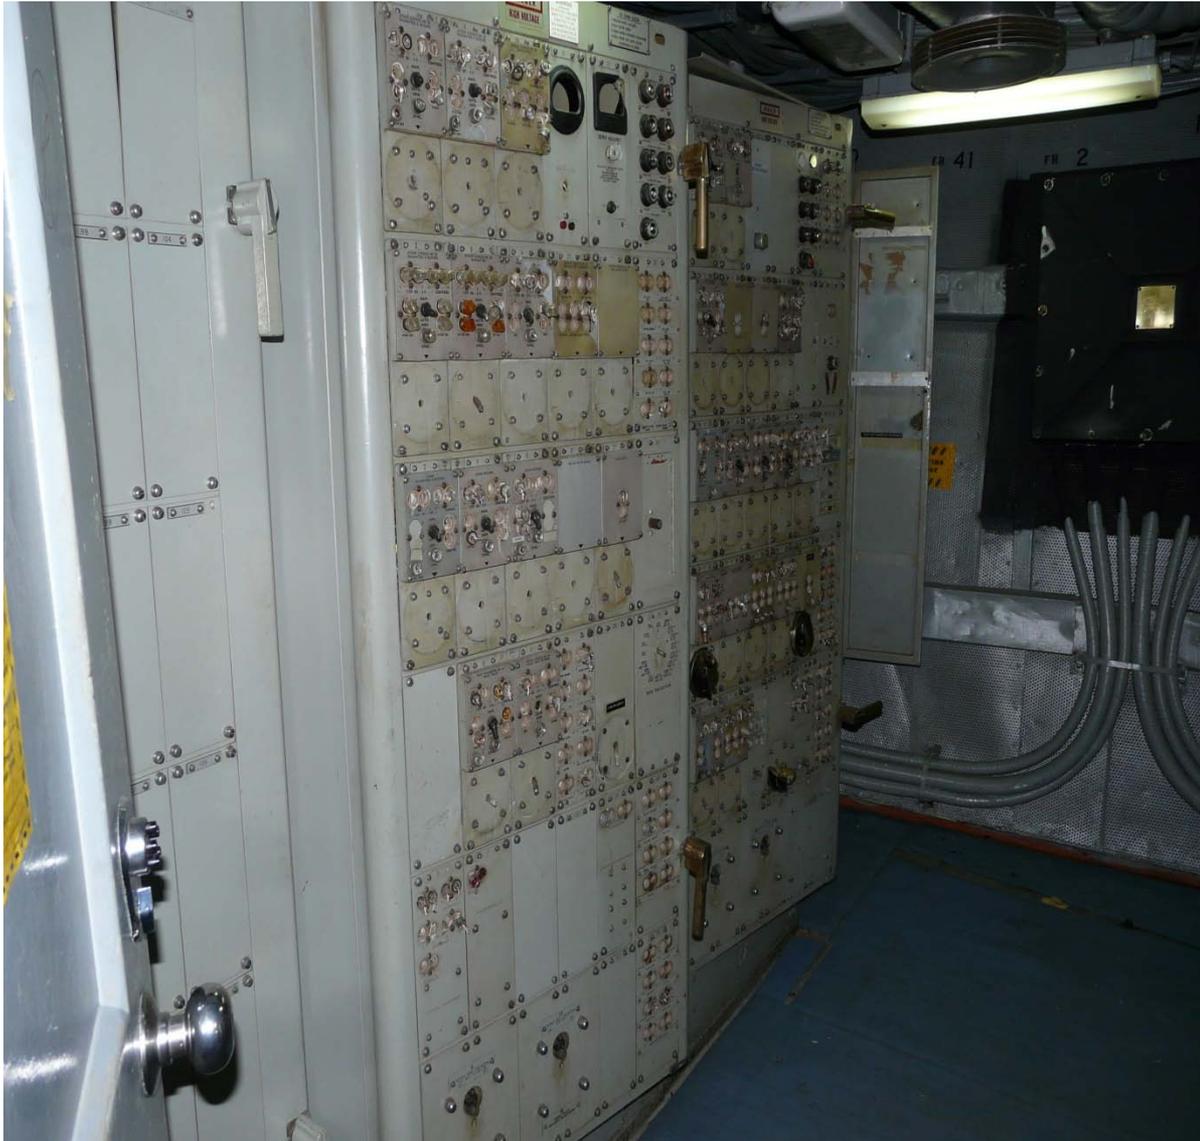
Sonar Room

Sonar switchboards which are similar in type to the missing ones in gun plot.

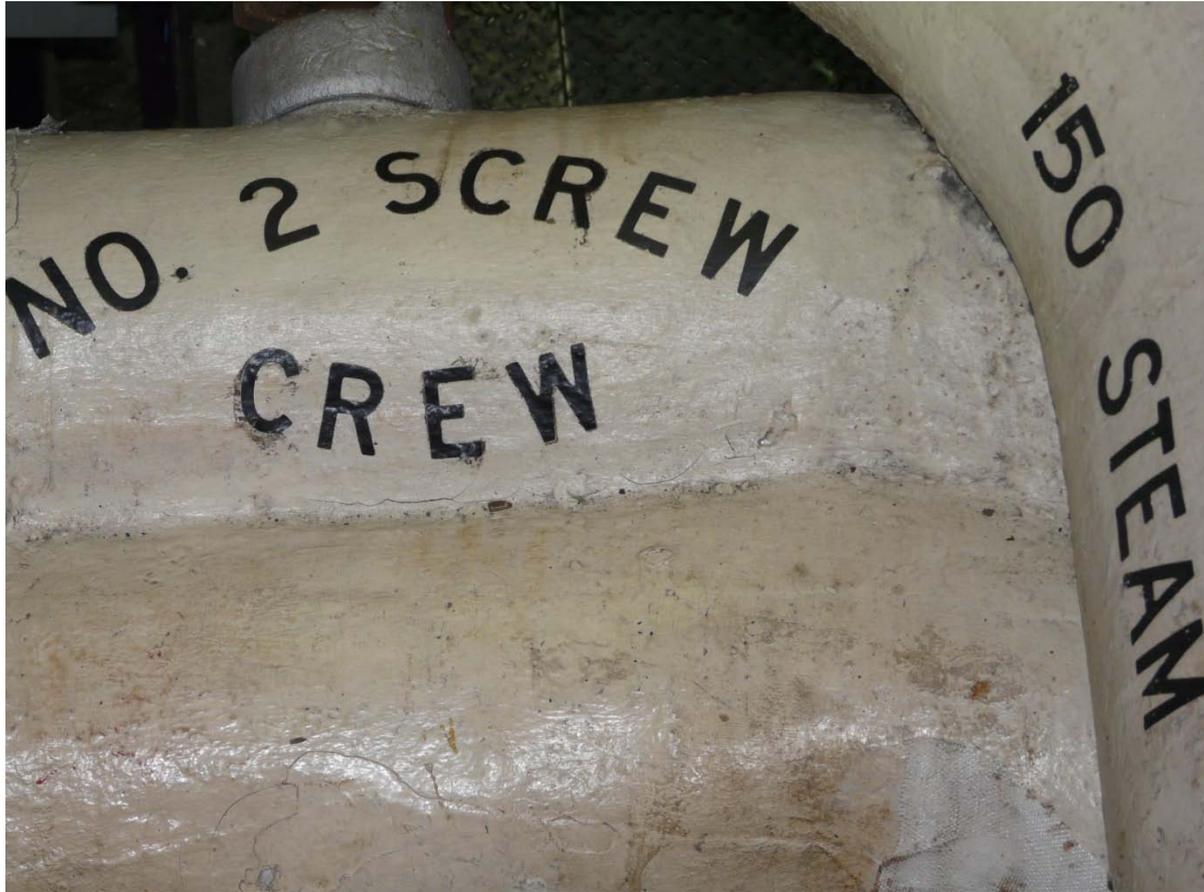
Aft Engine Room

Looking down the ladder in to the Aft Engine Room.

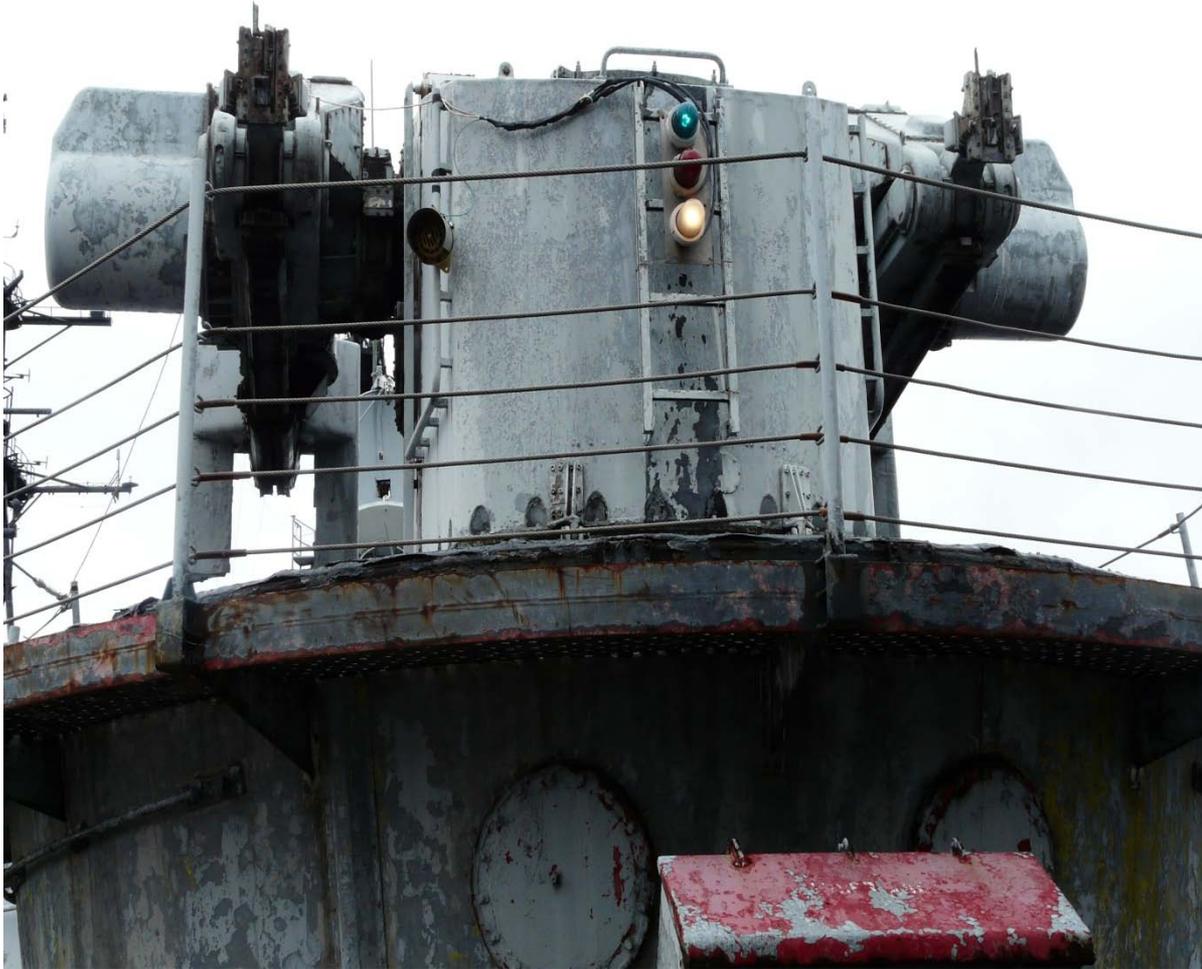
MK II Missile Launcher

From the fantail looking up at the launcher.

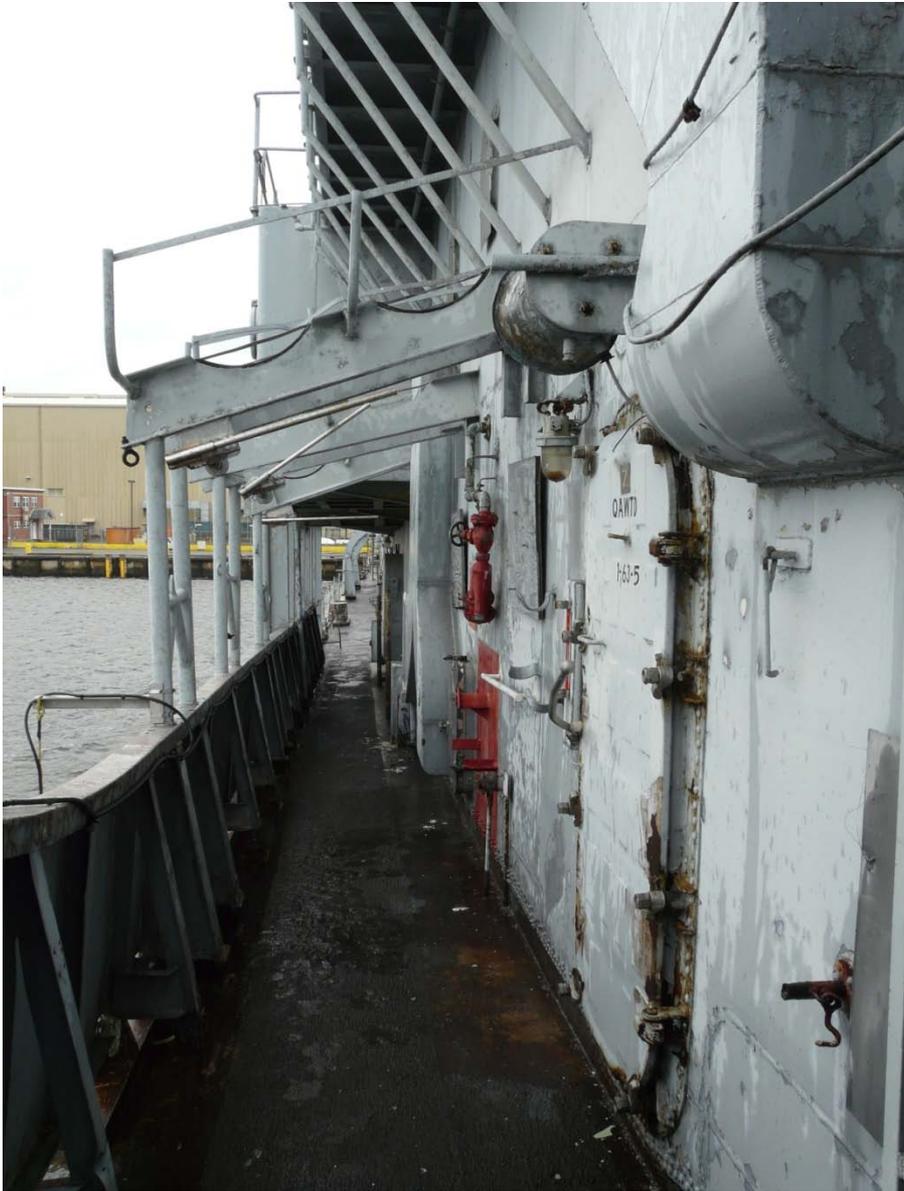
Main Deck

Starboard side main deck
looking aft.

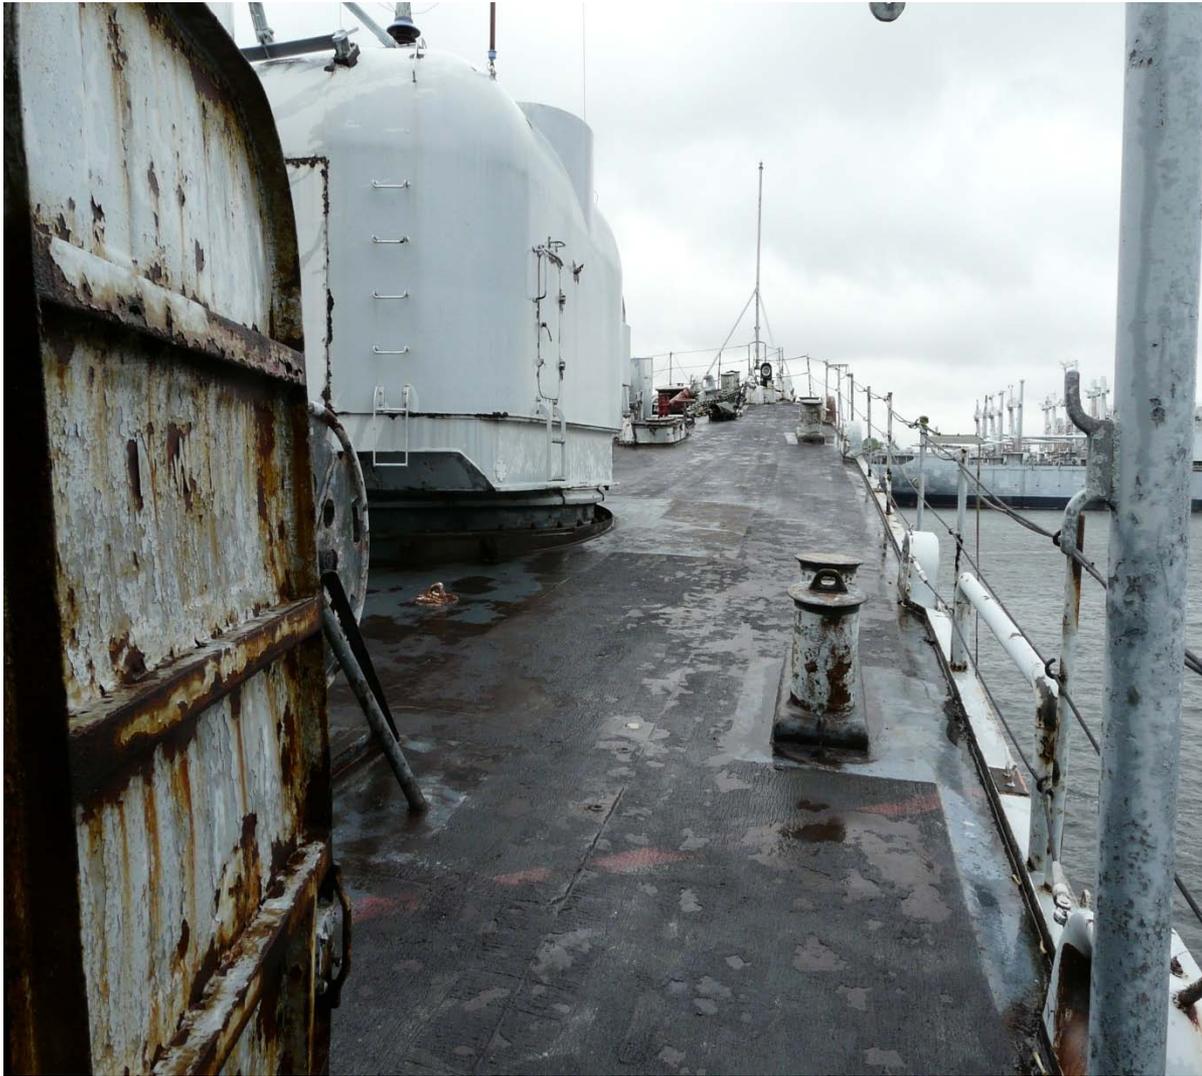
Main Deck

This is the main deck forward coming out of the hatch.
